COMPLIANCE ASBESTOS RE-INSPECTION AND RISK ASSESSMENT

NOVEMBER 2021

J033445

ROCKHAMPTON CITY CAMPUS_Block P - Canning Street
Canning Street
ROCKHAMPTON QLD
4700

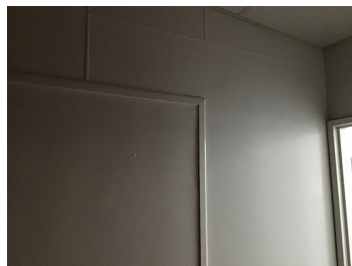
Location		Block P - Ground Floor - Corridor - Walls - Fibre cement sheet - North, East & West elevations

Hazard Type		Asbestos	Material Assessment		Disturbance Assessment		
Friability		Non-friable	Product Type	1	Occupancy		1
Sample No.		3-887 (AO000131)	Extent of damage	0	Disturbance		1
Result		Positive Chrysotile	Surface Treatment	1	Exposure		0
			Asbestos Type	1	Maintenance		0
Item Number		1	Material Score	3	Disturbance Score		2
			Priority Score	5	Very Low		
No Additional Photographic Evidence Available

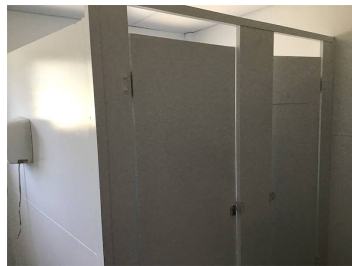
Location		Block P - Ground Floor - Male Bathroom - Partition wall - Fibre cement sheet - Central

Hazard Type		Asbestos	Material Assessment		Disturbance Assessment		
Friability		Non-friable	Product Type	1	Occupancy		0
Sample No.		3-888 {AO000132}	Extent of damage	0	Disturbance		1
Result		Positive Chrysotile	Surface Treatment	1	Exposure		0
			Asbestos Type	1	Maintenance		0
Item Number		2	Material Score	3	Disturbance Score		1
			Priority Score	4	Very Low		
No Additional Photographic Evidence Available

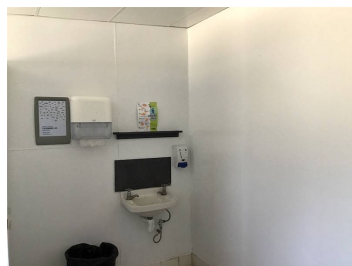
Location		Block P - Ground Floor - Male Bathroom - Walls - Fibre cement sheet - All elevations

Hazard Type		Asbestos	Material Assessment		Disturbance Assessment		
Friability		Non-friable	Product Type	1	Occupancy		1
Sample No.		As 3-887 {AO000131}	Extent of damage	0	Disturbance		1
Result		Strongly Assumed Positive Chrysotile	Surface Treatment	1	Exposure		0
			Asbestos Type	1	Maintenance		0
Item Number		3	Material Score	3	Disturbance Score		2
			Priority Score	5	Very Low		
No Additional Photographic Evidence Available

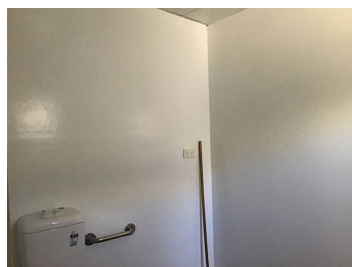
Location		Block P - Ground Floor - Female Bathroom - Walls - Fibre cement sheet - All elevations

Hazard Type		Asbestos	Material Assessment		Disturbance Assessment		
Friability		Non-friable	Product Type	1	Occupancy		1
Sample No.		As 3-887 {AO000131}	Extent of damage	0	Disturbance		1
Result		Strongly Assumed Positive Chrysotile	Surface Treatment	1	Exposure		0
			Asbestos Type	1	Maintenance		0
Item Number		4	Material Score	3	Disturbance Score		2
			Priority Score	5	Very Low		
No Additional Photographic Evidence Available

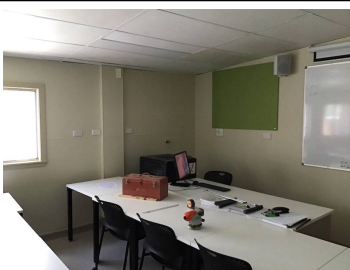
Location		Block P - Ground Floor - Classroom - Walls - Fibre cement sheet - North & East elevation				
Hazard Type		Asbestos	Material Assessment		Disturbance Assessment	
Friability		Non-friable	Product Type	1	Occupancy	1
Sample No.		As 3-887 {AO000131}	Extent of damage	0	Disturbance	1
Result		Strongly Assumed Positive Chrysotile	Surface Treatment	1	Exposure	0
			Asbestos Type	1	Maintenance	0
Item Number		5	Material Score	3	Disturbance Score	2
			Priority Score	5	Very Low	
No Additional Photographic Evidence Available

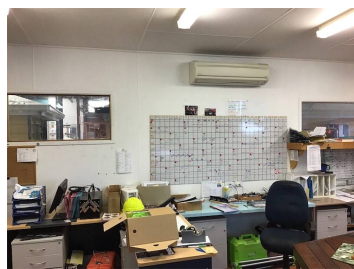
Location		Block P - Ground Floor - Staff Room - Walls - Fibre cement sheet - All elevations

Hazard Type		Asbestos		Material Assessment			Disturbance Assessment		
Friability		Non-friable		Product Type			1	Occupancy	1
Sample No.		As 3-887 {AO000131}		Extent of damage			0	Disturbance	1
Result		Strongly Assumed Positive Chrysotile		Surface Treatment			1	Exposure	0
				Asbestos Type			1	Maintenance	0
Item Number		7		Material Score			3	Disturbance Score	2
				Priority Score			5	Very Low	
No Additional Photographic Evidence Available

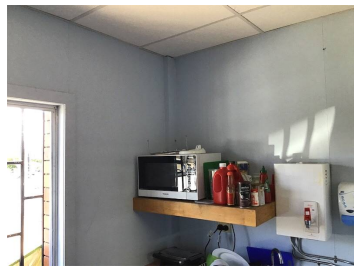
Location		Block P - Ground Floor - Lunch Room - Walls - Fibre cement sheet - East, South & West elevations

Hazard Type		Asbestos	Material Assessment		Disturbance Assessment		
Friability		Non-friable	Product Type	1	Occupancy		0
Sample No.		As 3-887 (AO000131)	Extent of damage	0	Disturbance		1
Result		Strongly Assumed Positive Chrysotile	Surface Treatment	1	Exposure		0
			Asbestos Type	1	Maintenance		0
Item Number		8	Material Score	3	Disturbance Score		1
			Priority Score	4	Very Low		
No Additional Photographic Evidence Available

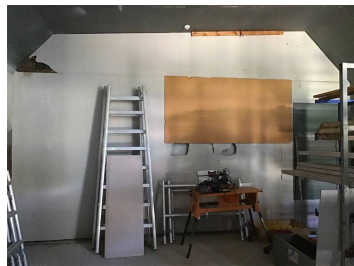
Item No.	Hazard Type	Item Location and Description	Recommendations
Item 9	Asbestos	Block P, Ground Floor, Storeroom, East elevation, Wall - Fibre cement sheet	Encapsulate / Repair & Manage In Situ Damage to sheet

Location		Block P - Ground Floor - Storeroom - Wall - Fibre cement sheet - East elevation

Hazard Type		Asbestos	Material Assessment		Disturbance Assessment		
Friability		Non-friable	Product Type	1	Occupancy		0
Sample No.		As 3-887 {AO000131}	Extent of damage	2	Disturbance		1
Result		Strongly Assumed Positive Chrysotile	Surface Treatment	1	Exposure		0
			Asbestos Type	1	Maintenance		0
Item Number		9	Material Score	5	Disturbance Score		1
			Priority Score	6	Very Low		
No Additional Photographic Evidence Available
