COMPLIANCE ASBESTOS RE-INSPECTION AND RISK ASSESSMENT

NOVEMBER 2021

J033429

CLERMONT CAMPUS_Clermont Property
17 Daintree St
Clermont
Clermont QLD
4721

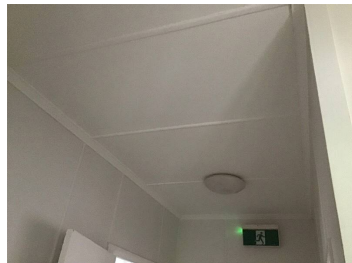
Location		17 Daintree Street - Ground Floor - Front Entrance Hallway - Throughout Ceiling - Fibre cement sheet							
Hazard Type		Asbestos		Material Assessment		Disturbance Assessment			
Friability		Non-friable		Product Type		1 Occupancy		0	
Sample No.		As 1-002 (AO000259)		Extent of damage		0 Disturbance		1	
Result		Strongly Assumed Positive Chrysotile		Surface Treatment		1 Exposure		2	
				Asbestos Type		1 Maintenance		0	
Item Number		6		Material Score		3 Disturbance Score		3	
				Priority Score		6 Very Low

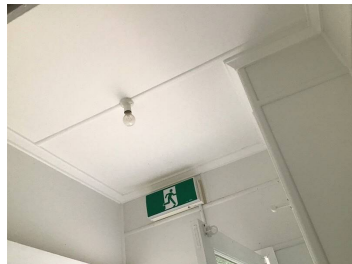
Location		17 Daintree Street - Ground Floor - Back Entrance Hallway - Throughout Ceiling - Fibre cement sheet

Hazard Type		Asbestos		Material Assessment			Disturbance Assessment		
Friability		Non-friable		Product Type			1	Occupancy	0
Sample No.		As 1-002 {AO000259}		Extent of damage			0	Disturbance	1
Result		Strongly Assumed Positive Chrysotile		Surface Treatment			1	Exposure	2
				Asbestos Type			1	Maintenance	0
Item Number		7		Material Score			3	Disturbance Score	3
				Priority Score			6	Very Low

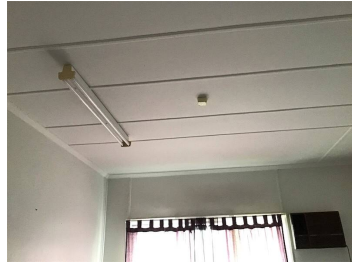
Location		17 Daintree Street - Ground Floor - Reception - Throughout Ceiling - Fibre cement sheet				
Hazard Type		Asbestos	Material Assessment		Disturbance Assessment	
Friability		Non-friable	Product Type	1	Occupancy	0
Sample No.		As 1-002 (AO000259)	Extent of damage	0	Disturbance	1
Result		Strongly Assumed Positive Chrysotile	Surface Treatment	1	Exposure	2
			Asbestos Type	1	Maintenance	0
Item Number	8	Material Score	3	Disturbance Score	3	
		Priority Score	6	Very Low

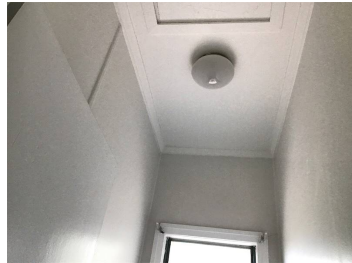
Location	17 Daintree Street - Ground Floor - Toilet - Throughout Ceiling - Fibre cement sheet

Hazard Type	Asbestos	Material Assessment	Disturbance Assessment			
Friability	Non-friable	Product Type	1	Occupancy		0
Sample No.	As 1-002 (AO000259)	Extent of damage	0	Disturbance		1
Result	Strongly Assumed Positive Chrysotile	Surface Treatment	1	Exposure		2
		Asbestos Type	1	Maintenance		0
Item Number	10	Material Score	3	Disturbance Score		3
		Priority Score	6	Very Low

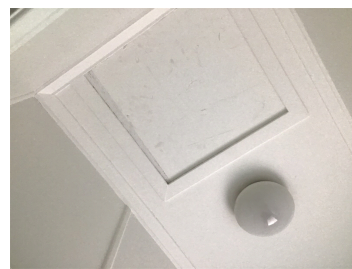
Location		17 Daintree Street - Ground Floor - Toilet - Central Ceiling access hatch - Fibre cement				
Hazard Type		Asbestos	Material Assessment		Disturbance Assessment	
Friability		Non-friable	Product Type	1	Occupancy	0
Sample No.		As 1-002 {AO000259}	Extent of damage	0	Disturbance	1
Result		Strongly Assumed Positive Chrysotile	Surface Treatment	1	Exposure	2
			Asbestos Type	1	Maintenance	0
Item Number		11	Material Score	3	Disturbance Score	3
			Priority Score	6	Very Low

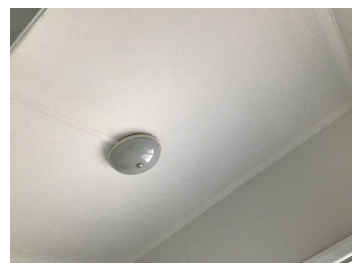
Location		17 Daintree Street - Ground Floor - Main Bathroom - Throughout Ceiling - Fibre cement sheet									
Hazard Type		Asbestos		Material Assessment		Disturbance Assessment					
Friability		Non-friable		Product Type		1 Occupancy		0			
Sample No.		As 1-002 {AO000259}		Extent of damage		0 Disturbance		1			
Result		Strongly Assumed Positive Chrysotile		Surface Treatment		1 Exposure		2			
				Asbestos Type		1 Maintenance		0			
Item Number		12		Material Score		3 Priority Score		Disturbance Score		3 Very Low

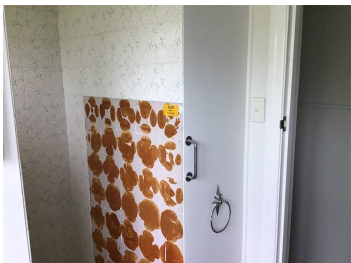
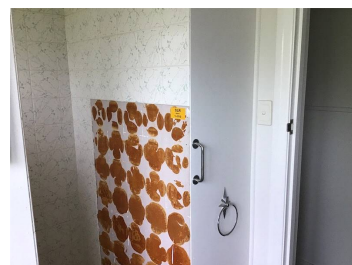
Location		17 Daintree Street - Ground Floor - Main Bathroom - All elevations Walls - Fibre cement sheet						
Hazard Type		Asbestos		Material Assessment		Disturbance Assessment		
Friability		Non-friable		Product Type		1	Occupancy	0
Sample No.		1-012 (AO000262)		Extent of damage		0	Disturbance	1
Result		Positive Chrysotile		Surface Treatment		1	Exposure	2
				Asbestos Type		1	Maintenance	0
Item Number		17		Material Score		3	Disturbance Score	3
				Priority Score		6	Very Low

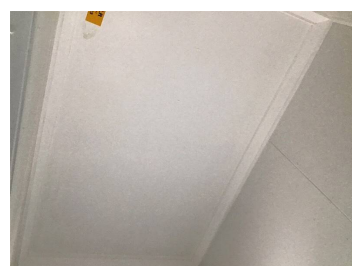
Location		17 Daintree Street - Ground Floor - Main Bathroom - Throughout Shower ceiling - Fibre cement sheet					
Hazard Type		Asbestos		Material Assessment		Disturbance Assessment	
Friability		Non-friable		Product Type		1Occupancy0	
Sample No.		1-013 {AO000263}		Extent of damage		0Disturbance1	
Result		Positive Chrysotile		Surface Treatment		1Exposure2	
				Asbestos Type		1Maintenance0	
Item Number		18		Material Score		3Disturbance Score3	
				Priority Score		6Very Low

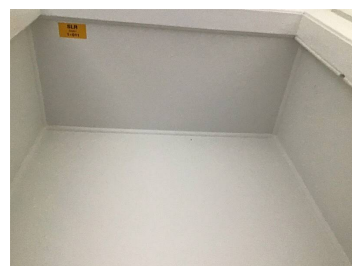
Location	17 Daintree Street - Ground Floor - Fire Reel Cupboard - Throughout Ceiling - Fibre cement sheet				
Hazard Type	Asbestos	Material Assessment		Disturbance Assessment	
Friability	Non-friable	Product Type	1	Occupancy	0
Sample No.	1-011 {AO000261}	Extent of damage	0	Disturbance	1
Result	Positive Chrysotile	Surface Treatment	1	Exposure	0
		Asbestos Type	1	Maintenance	0
Item Number	13	Material Score	3	Disturbance Score	1
		Priority Score	4	Very Low

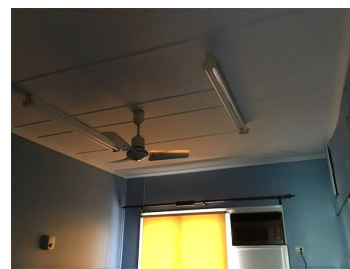
Location		17 Daintree Street - Ground Floor - Office 1 - Throughout Ceiling - Fibre cement sheet					
Hazard Type		Asbestos	Material Assessment		Disturbance Assessment		
Friability		Non-friable	Product Type	1	Occupancy	0	
Sample No.		As 1-002 (AO000259)	Extent of damage	0	Disturbance	1	
Result		Strongly Assumed Positive Chrysotile		Surface Treatment	1	Exposure	2
				Asbestos Type	1	Maintenance	0
Item Number		14		Material Score	3	Disturbance Score	3
				Priority Score	6	Very Low

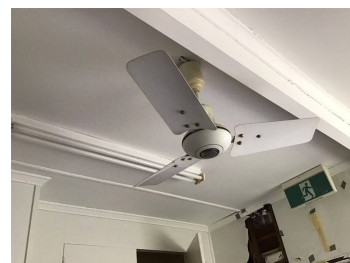
Location		17 Daintree Street - Ground Floor - Office 2 - Flat - West section Ceiling - Fibre cement sheet									
Hazard Type		Asbestos		Material Assessment		Disturbance Assessment					
Friability		Non-friable		Product Type		1		Occupancy		0	
Sample No.		As 1-002 {AO000259}		Extent of damage		0		Disturbance		1	
Result		Strongly Assumed Positive Chrysotile		Surface Treatment		1		Exposure		2	
				Asbestos Type		1		Maintenance		0	
Item Number		15		Material Score		3		Disturbance Score		3	
				Priority Score		6		Very Low

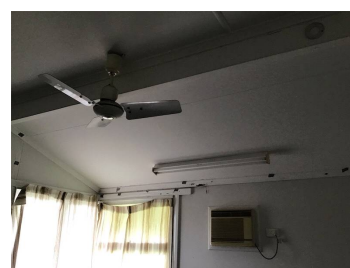
Location	17 Daintree Street - Ground Floor - Office 2 - Slopped - East section Ceiling - Fibre cement sheet				
Hazard Type	Asbestos	Material Assessment		Disturbance Assessment	
Friability	Non-friable	Product Type	1	Occupancy	0
Sample No.	1-014 (AO000264)	Extent of damage	0	Disturbance	1
Result	Positive Chrysotile	Surface Treatment	1	Exposure	2
		Asbestos Type	1	Maintenance	0
Item Number	19	Material Score	3	Disturbance Score	3
		Priority Score	6	Very Low

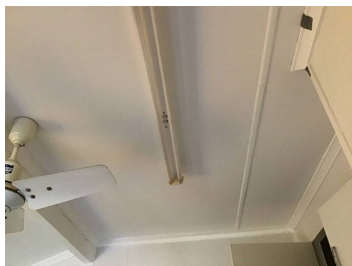
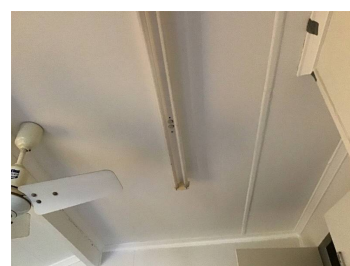
Location		17 Daintree Street - Ground Floor - Office 3 - Flat - West section Ceiling - Fibre cement sheet							
Hazard Type		Asbestos		Material Assessment		Disturbance Assessment			
Friability		Non-friable		Product Type		1	Occupancy	0	
Sample No.		As 1-002 {AO000259}		Extent of damage		0	Disturbance	1	
Result		Strongly Assumed Positive Chrysotile		Surface Treatment		1	Exposure	2	
				Asbestos Type		1	Maintenance	0	
Item Number		16		Material Score		3	Disturbance Score		3
				Priority Score		6	Very Low

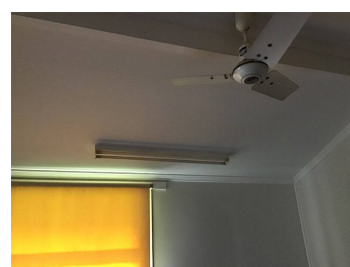
Location	17 Daintree Street - Ground Floor - Office 3 - Sloped - East section Ceiling - Fibre cement sheet				
Hazard Type	Asbestos	Material Assessment		Disturbance Assessment	
Friability	Non-friable	Product Type	1	Occupancy	0
Sample No.	As 1-014 (AO000264)	Extent of damage	0	Disturbance	1
Result	Strongly Assumed Positive Chrysotile	Surface Treatment	1	Exposure	2
		Asbestos Type	1	Maintenance	0
Item Number	20	Material Score	3	Disturbance Score	3
		Priority Score	6	Very Low

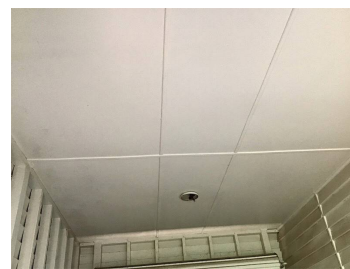
Location		17 Daintree Street - Ground Floor - Garage - Throughout Ceiling - Fibre cememt sheet					
Hazard Type		Asbestos		Material Assessment		Disturbance Assessment	
Friability		Non-friable		Product Type		1	
Sample No.		As 1-002 {AO000259}		Extent of damage		0	
Result		Strongly Assumed Positive Chrysotile		Surface Treatment		1	
				Asbestos Type		1	
Item Number		21		Material Score		3	
				Priority Score		5	
				Occupancy		0	
				Disturbance		1	
				Exposure		1	
				Maintenance		0	
				Disturbance Score		2	
						Very Low

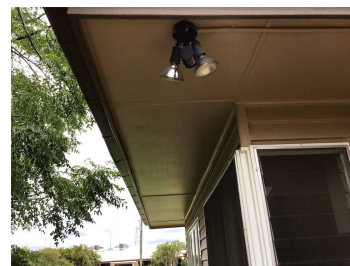
Location		17 Daintree Street - Ground Floor - External - All elevations Soffits - Fibre cement sheet					
Hazard Type		Asbestos		Material Assessment		Disturbance Assessment	
Friability		Non-friable		Product Type		1	
Sample No.		1-016 (AO000265)		Extent of damage		0	
Result		Positive Chrysotile		Surface Treatment		1	
				Asbestos Type		1	
Item Number		23		Material Score		3	
				Priority Score		4	
				Occupancy		0	
				Disturbance		1	
				Exposure		0	
				Maintenance		0	
				Disturbance Score		1	
				Very Low

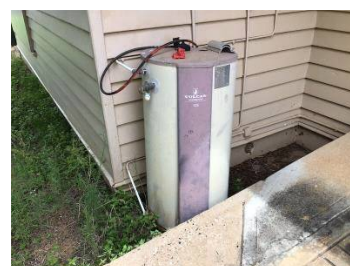
Location		17 Daintree Street - Ground Floor - External - South Elevation Hot water system - Insulating board					
Hazard Type		Asbestos		Material Assessment		Disturbance Assessment	
Friability		Friable		Product Type		2	
Sample No.		Visual		Extent of damage		0	
Result		Assumed Positive Unknown or Crocidolite		Surface Treatment		0	
				Asbestos Type		3	
Item Number		34		Material Score		5	
				Priority Score		6	
				Occupancy		0	
				Disturbance		1	
				Exposure		0	
				Maintenance		0	
				Disturbance Score		1	
				Very Low
