Division 5 Asbestos Register

Re-Inspection Regulatory Compliance for Workplaces

99 Thistlethwaite Street
SOUTH MELBOURNE, VIC 3205

Report No : 1340.02.ARI Rev 0
Client : GMCCA Pty Ltd ATF Chan 2015 Family Trust
Surveyed : 27 November 2024
Issued : 20 December 2024

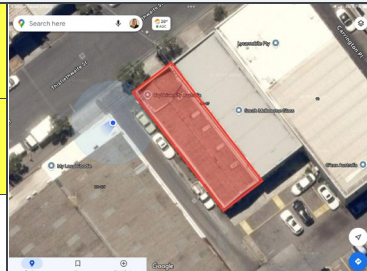
Location		Assessment Details	Risk	Photo	Controls
99 Thistlethwaite St - Exterior					
ASBESTOS	Roof Corrugated asbestos cement sheeting	Method Sampled in Previous Audit (1340.01/AS01) Outcome Chrysotile & Amosite Asbestos Detected Condition Good Extent 320.0 square metres	Low Risk Priority P3

Maintain in good condition & do not disturb - e.g. do not drill, cut, grind, sand, or blast. Remove prior to any works that may disturb the materials by a Licensed Class A or Class B Asbestos Removalist. Engage a Hygienist such as Greenlight to visually inspect any removal works & issue a clearance certificate prior to normal occupancy. Air monitoring is
			Non-Friable Asbestos Class A / B License Required		
ASBESTOS	Roof Roof box gutters - may contain build-up of asbestos dust & debris	Method Visually Assessed Outcome Assumed to Contain Asbestos Condition Moderate Extent 20.0 square metres Labelled? Not Required (Height)	Medium Risk Priority P2

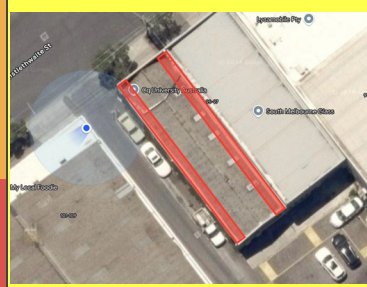
Run-off from asbestos roofing in degrading condition can cause contamination in the guttering. Ideally the roof should be sealed or consider removal to prevent this kind of occurrence. (Note you cannot perform paint prep on the asbestos roof) Alternatively, Gutters can be first cleaned by a Licensed Class A Asbestos removalist.

Friable Asbestos Class A License Required

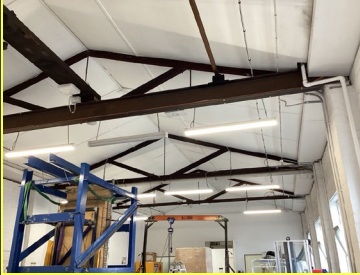
Location		Assessment Details	Risk	Photo	Controls
99 Thistlethwaite St - Ceiling Cavity					
ASBESTOS	Space between Asbestos Roof & Internal Ceilings	Method Visually Assessed	Medium Risk Priority P2 Friable Asbestos Class A License Required

Avoid any drilling, cutting or grinding of the ceiling material. Confirm Status & remove as soon as practicable and prior to any demolition or refurbishment works that will disturb the materials by a licensed Class A Asbestos Removalist. Engage a Hygienist such as Greenlight to visually inspect any removal works, carry out air monitoring both during & following removal & to issue a clearance certificate prior to normal occupancy.
	Build-up of asbestos dust likely present	Outcome Assumed to Contain Asbestos			
		Condition Good			
		Extent 300.0 square metres			
		Labelled? Not Required (Height)
