COMPLIANCE ASBESTOS RE-INSPECTION AND RISK ASSESSMENT

NOVEMBER 2021

J033475

ROCKHAMPTON NORTH CAMPUS_RES Building 059 - Cap College Comp Tute and Board Room Bruce Highway ROCKHAMPTON NORTH QLD 4700

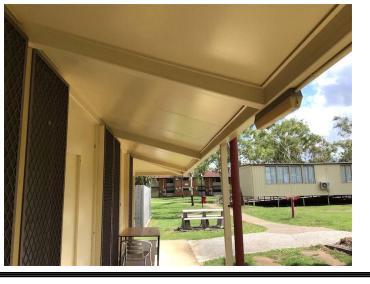
Location	059 Study Centre - Ground Floor - External - Skylight - North & South - Gable - Fibre cement sheet						
Hazard Type	Asbestos	Material Assessm	ient	Disturbance Assess	ment		
Friability	Non-friable	Product Type	1	Occupancy	0		
Sample No.	Visual	Extent of damage	0	Disturbance	0		
	Assumed Positive	Surface Treatment	1	Exposure	0		
Result	Crocidolite	Asbestos Type	3	Maintenance	0		
Item Number	2	Material Score	5	Disturbance Score	0		
	2	Priority Score	5	Very Low

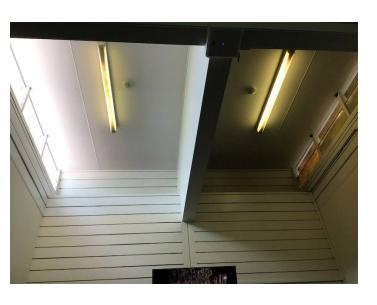
Location	059 Study Centre - Ground Floor - Computer Lab - Throughout - Skylight ceiling - Fibre cement sheet						
Hazard Type	Asbestos	Material Assessm	ent	Disturbance Assess	ment		
Friability	Non-friable	Product Type	1	Occupancy	0		
Sample No.	As 1-289 {AO000229}	Extent of damage	0	Disturbance	1		
Decult	Strongly Assumed	Surface Treatment	1	Exposure	0		
Result Positive Chrysotile Amosite	Amosite	Asbestos Type	2	Maintenance	0		
Item Number	4	Material Score	4	Disturbance Score	1		
	4	Priority Score	5	Very Low

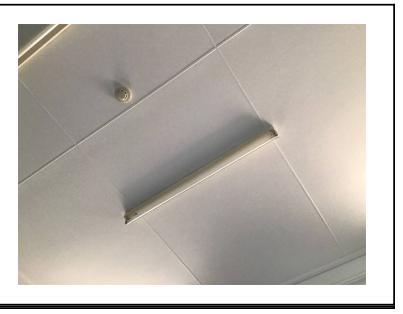
Location	059 Study Centre - Ground Floor - Tutorial Room 3 - Throughout - Ceiling - Fibre cement sheet							
Hazard Type	Asbestos	Material Assessmen	t	Disturbance Assessme	nt			
Friability	Non-friable	Product Type	1	Occupancy	0			
Sample No.	1-292 {AO000230}	Extent of damage	0	Disturbance	1			
Result	Positive Chrysotile +	Surface Treatment	1	Exposure	0			
	Amosite	Asbestos Type	2	Maintenance	0			
Item Number	F	Material Score	4	Disturbance Score	1			
	່ <u>ບ</u>	Priority Score	5	Very Low
