# ASBESTOS CONTAINING MATERIALS SURVEY REPORT

Campus Security  
Rockhampton North

CQ University Asbestos Audits

**Campus Security - Ground Floor**  
**Bruce Highway, Rockhampton North,**  
**QLD 4702**

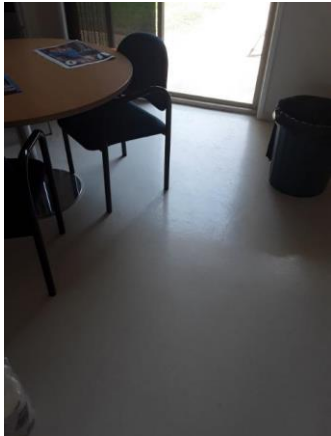
Sample No./ Visual Observation	Photo	Location			Analysis
		Int / Ext Floor Specific Location	Material Application	Extent	Result
1-312

External Kitchen floor	Floor vinyl, Vinyl Products	20m <sup>2</sup>	NAD

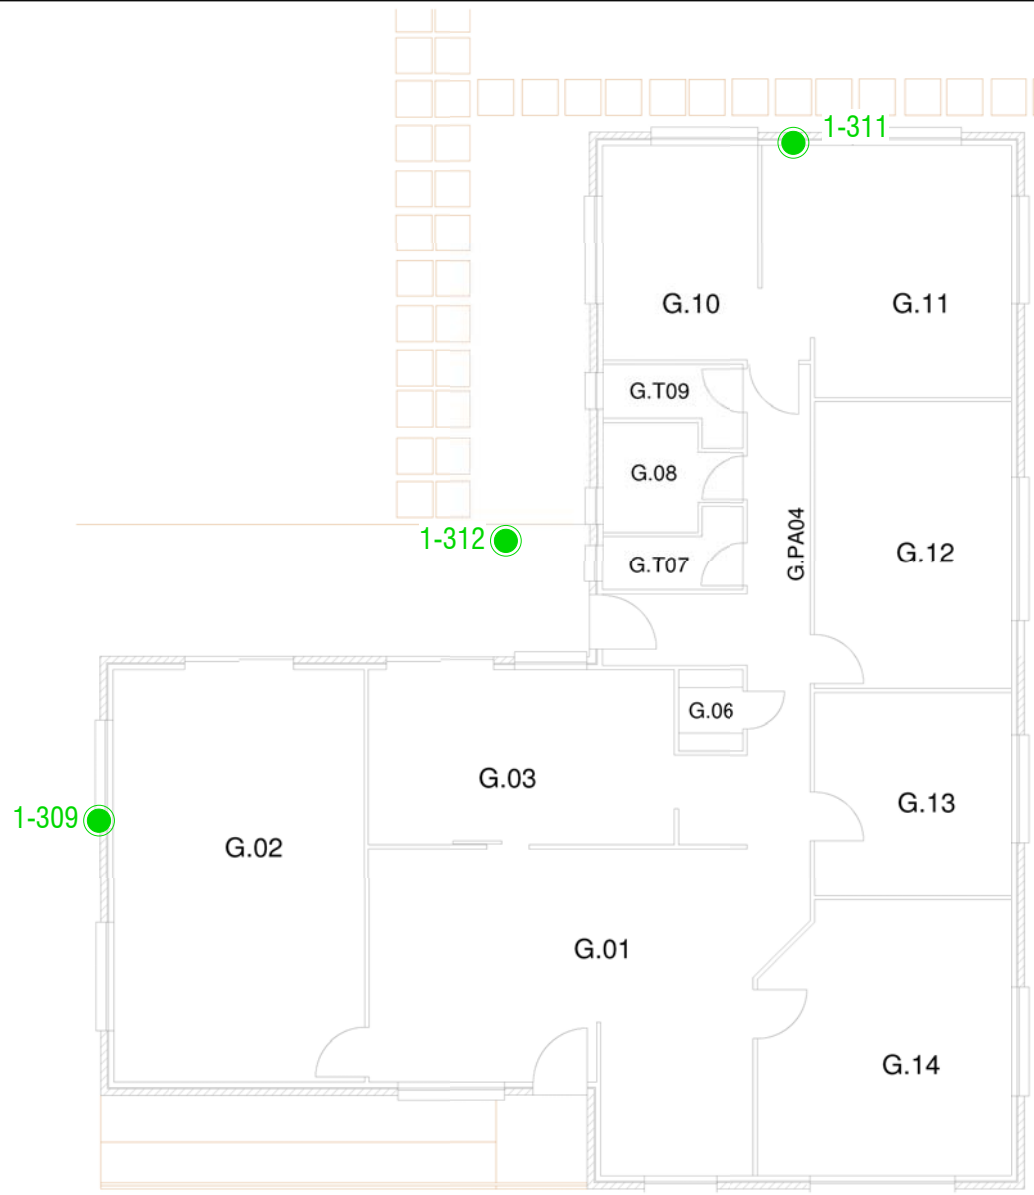
Building No:	03
Inspection Date:	Sept / Oct 2017
Inspected By:	NC / JH / SA
Figure No.:	SLR62210968-RN-03G-01
Drawn By:	LF
Drawn Date:	18/1/18

- Sample location.
- No Asbestos Detected
