# ASBESTOS CONTAINING MATERIALS SURVEY REPORT

BLD 200 - Vacant  
Rockhampton North

Reference	Date	Prepared	Checked	Authorised
622.10968.00000/0040-R01-v1	01 December 2017	Jordan Harley	Narelle Carnes	Narelle Carnes

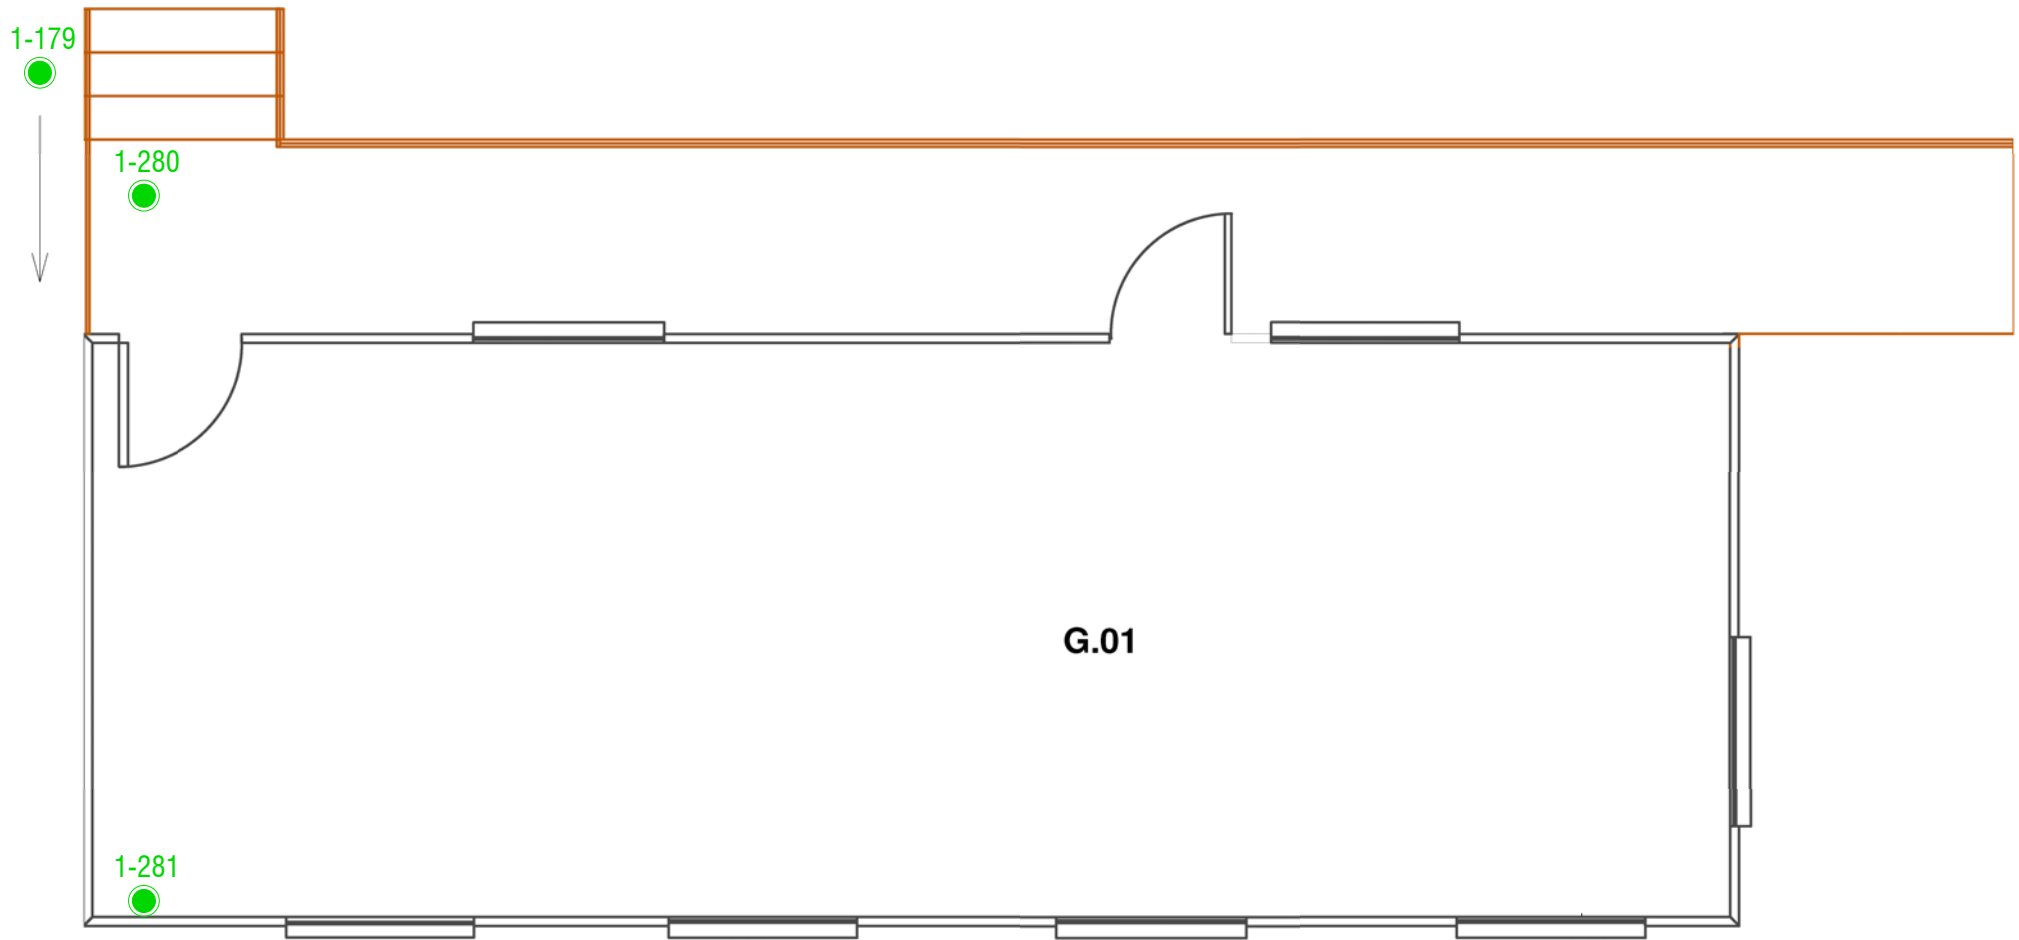
Building No:	200
Inspection Date:	Sept / Oct 2017
Inspected By:	NC / JH / SA
Figure No.:	SLR62210968-RN-200G-01
Drawn By:	LF
Drawn Date:	18/1/18

Sample location. No Asbestos Detected.
