ASBESTOS AND HAZARDOUS MATERIALS REGISTER

10 William Street, Perth WA 6000

Report ID: **31730r0**

Prepared for: **Knight Frank Pty Ltd**

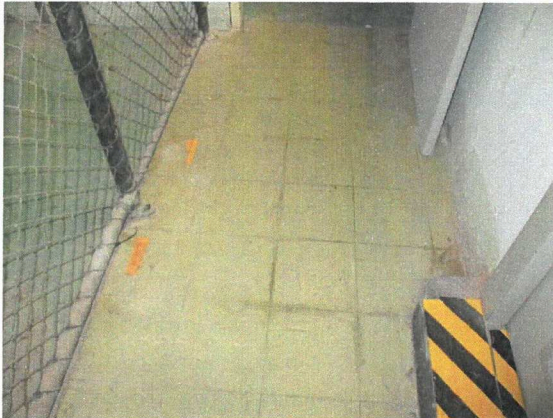
ID 1:- Vinyl Floor Tiles, Pale Green (Asbestos Detected)	
Material	Chrysotile asbestos detected.
Lab No.	BL-0165 PB
QED Sample No.	N/A
Locations	Basement Transformer Room
Condition	Good to Fair, non-friable.
Signage	Labelled
Potential for Disturbance	Low
Risk	The ACM are not friable and are in stable condition. Ensure that they remain clearly labelled and regularly inspect to ensure they are not deteriorating or otherwise contributing to an unacceptable health risk.
Management Actions	May remain in-situ until replacement is required. Manage as per Asbestos Management Plan . Administrative – Follow safe work procedures during removal and maintenance. Personal protective equipment – P2 facemask and coveralls required when working on material.
References (See Appendices)	Safe Work Australia, Code of Practice: How to Manage and Control Asbestos in the Workplace. WHS Appendix F—Example of asbestos-related work Working with asbestos friction materials WHS Appendix G—Recommended safe working practices Safe work practice 1—Drilling of ACM Safe Work Australia, Code of Practice: How to Safely Remove Asbestos Appendix E—Examples of asbestos removal work Removal of floor tiles

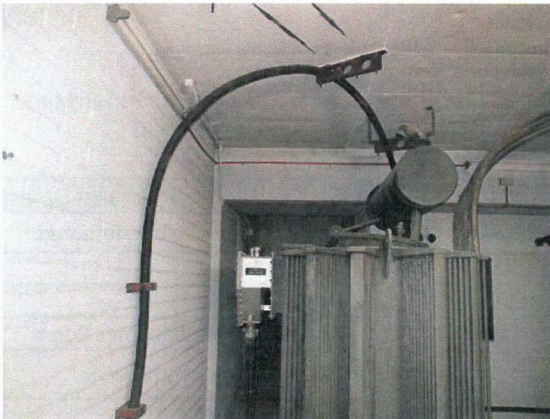
ID 2:- High Voltage Wiring Outer Sheath (Suspected Asbestos Containing Material)

Material	Suspected asbestos containing material.	
Lab No.	Unable to obtain suitable sample (Live).	
QED Sample No.	N/A.	
Locations	Basement Transformer Room	
Condition	Good, non-friable.	
Signage	None – not practical to label	
Potential for Disturbance	Low	
Risk	The ACM are not friable and are in stable condition. Ensure that they remain clearly labelled and regularly inspect to ensure they are not deteriorating or otherwise contributing to an unacceptable health risk.	
Management Actions	No access to the transformer compound is available to sample or label this item. May remain in-situ until replacement is required. Manage as per Asbestos Management Plan . Administrative – Follow safe work procedures during removal and maintenance. Personal protective equipment – P2 facemask and coveralls required when working on material.

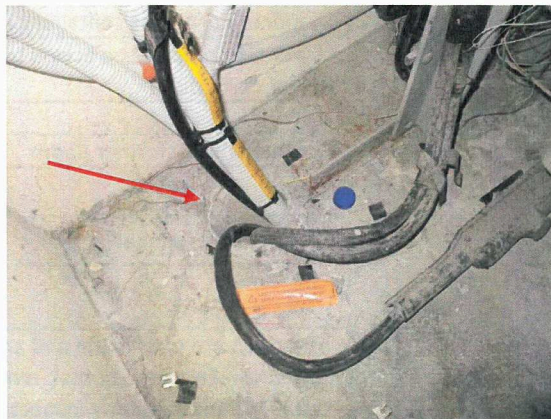
ID 4:- Fibre Cement Conduit (Asbestos Detected)	
Material	Chrysotile, amosite and crocidolite asbestos detected.
Lab No.	ARL Lab No 18-05571-2.
QED Sample No.	ID: 27014.
Locations	Basement communications cupboard.
Condition	Good, non-friable.
Signage	Labelled.
Potential for Disturbance	Low to Medium.
Risk	The ACM are not friable and are in stable condition.Ensure that they remain clearly labelled and regularly inspect to ensure they are not deteriorating or otherwise contributing to an unacceptable health risk.
Management Actions	May remain in-situ until replacement is required. Manage as per Asbestos Management Plan. Administrative – Follow safe work procedures during removal and maintenance. Personal protective equipment – P2 facemask and coveralls required when working on material. Conduit has been sealed in wall, use caution when drilling through walls.
References (See Appendices)	Safe Work Australia, Code of Practice: How to Manage and Control Asbestos in the Workplace. WHS Appendix G—Recommended safe working practices Safe work practice 1—Drilling of ACM Safe work practice 2—Sealing, painting, coating and cleaning of asbestos cement products Safe work practice 4—Replacing cabling in asbestos cement conduits or boxes Safe Work Australia, Code of Practice: How to Safely Remove Asbestos Appendix E—Examples of asbestos removal work Asbestos cement products

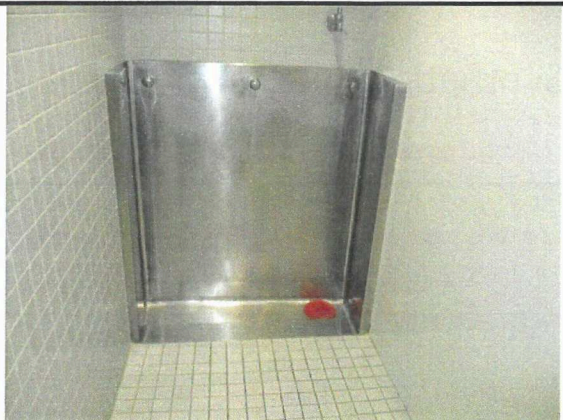
ID 5:- Urinal Backing Membrane (Suspected Asbestos Containing Material)

Material	Suspected asbestos containing material.	
Lab No.	Unable to sample (encapsulated)	
QED Sample No.	N/A.	
Locations	Male toilets on each level.	
Condition	Good, intact, non-friable.	
Signage	Unable to adequately label.	
Potential for Disturbance	Low.	
Risk	The ACM are not friable and are in stable condition. Ensure that they are regularly inspected to ensure they are not deteriorating or otherwise contributing to an unacceptable health risk.	
Management Actions	May remain in-situ until replacement is required. Manage as per Asbestos Management Plan . Administrative – Follow safe work procedures during removal and maintenance. Personal protective equipment – P2 facemask and coveralls required when working on material.	
References (See Appendices)	Safe Work Australia, Code of Practice: How to Manage and Control Asbestos in the Workplace. Safe Work Australia, Code of Practice: How to Safely Remove Asbestos Appendix E—Examples of asbestos removal work Removing bituminous (malthoid) products

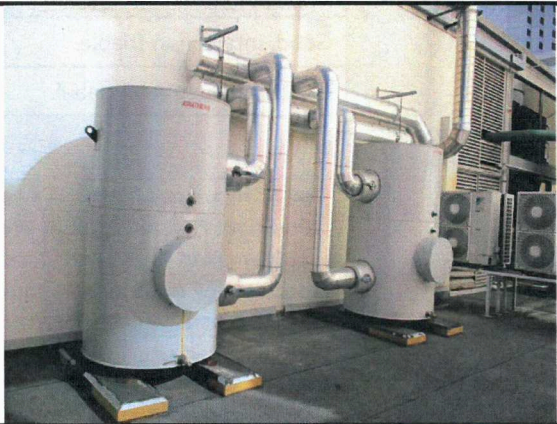
ID 6:- Chilled Water Storage Tank Insulation (Suspected Synthetic Mineral Fibres)

Material	Suspected synthetic mineral fibres.	
Lab No.	Observed.	
QED Sample No.	N/A	
Locations	Rooftop	
Condition	Good.	
Signage	N/A.	
Potential for Disturbance	Low.	
Risk	Minor	
Management Actions	Minimise disturbance / handling. Appropriate PPE required when disturbing, at least a P2 Mask. Removal by an appropriate contractor.	
References (See Appendices)	National Code of Practice for the Safe Use of Synthetic Mineral Fibres [NOHSC:2006(1990)].	
Service Record	N/A.

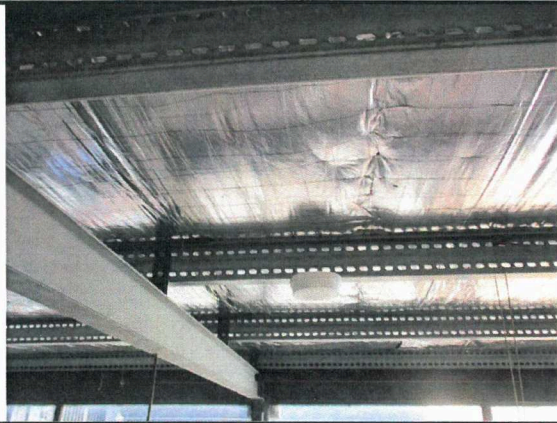
ID 7:- Roof Insulation (Suspected Synthetic Mineral Fibres)

Material	Suspected synthetic mineral fibres.	
Lab No.	Observed.	
QED Sample No.	N/A.	
Locations	Lift motor room and Level 7 Plantroom.	
Condition	Good.	
Signage	N/A.	
Potential for Disturbance	Low.	
Risk	Minor	
Management Actions	Minimise disturbance / handling. Appropriate PPE required when disturbing, at least a P2 Mask. Removal by an appropriate contractor.	
References (See Appendices)	National Code of Practice for the Safe Use of Synthetic Mineral Fibres [NOHSC:2006(1990)].	
Service Record	N/A.

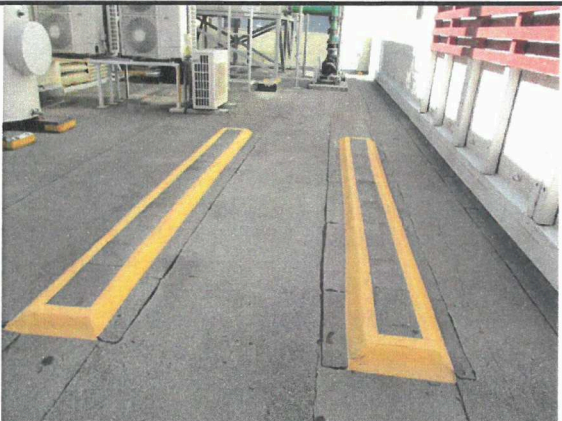
ID 8:- Waterproofing Membrane (Suspected Synthetic Mineral Fibres)

Material	Synthetic mineral fibres.	
Lab No.	MPL Lab 094573-001.	
QED Sample No.	N/A.	
Locations	Roof.	
Condition	Good.	
Signage	N/A.	
Potential for Disturbance	Low.	
Risk	Minor	
Management Actions	Minimise disturbance / handling. Appropriate PPE required when disturbing, at least a P2 Mask. Removal by an appropriate contractor.	
References (See Appendices)	National Code of Practice for the Safe Use of Synthetic Mineral Fibres [NOHSC:2006(1990)].	
Service Record	N/A.

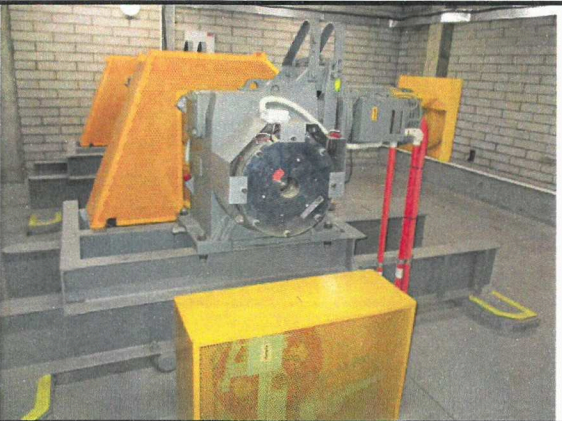
ID 9:- Lift Brakes (Synthetic Mineral Fibres Detected)

Material	Synthetic mineral fibres.	
Lab No.	MPL Lab 094573-003. Lift Motors and controllers replaced 2006.	
QED Sample No.	N/A.	
Locations	Lift motor room.	
Condition	Good.	
Signage	N/A.	
Potential for Disturbance	Low.	
Risk	Minor	
Management Actions	Minimise disturbance / handling. Appropriate PPE required when disturbing, at least a P2 Mask. Removal by an appropriate contractor.	
References (See Appendices)	National Code of Practice for the Safe Use of Synthetic Mineral Fibres [NOHSC:2006(1990)].	
Service Record	N/A.

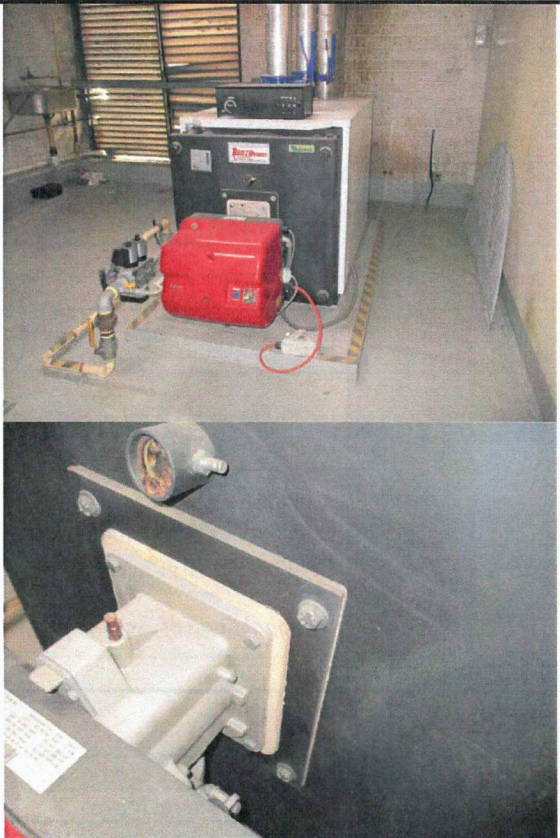
ID 10:- Boiler Gaskets & Insulation (Suspected Synthetic Mineral Fibres)

Material	Suspected synthetic mineral fibres.	
Lab No.	Observed. Boiler installed 2013.	
QED Sample No.	N/A.	
Locations	L7 Plantroom.	
Condition	Good.	
Signage	N/A.	
Potential for Disturbance	Low.	
Risk	Minor	
Management Actions	Minimise disturbance / handling. Appropriate PPE required when disturbing, at least a P2 Mask. Removal by an appropriate contractor.	
References (See Appendices)	<i>National Code of Practice for the Safe Use of Synthetic Mineral Fibres [NOHSC:2006(1990)].</i>	
Service Record	N/A.

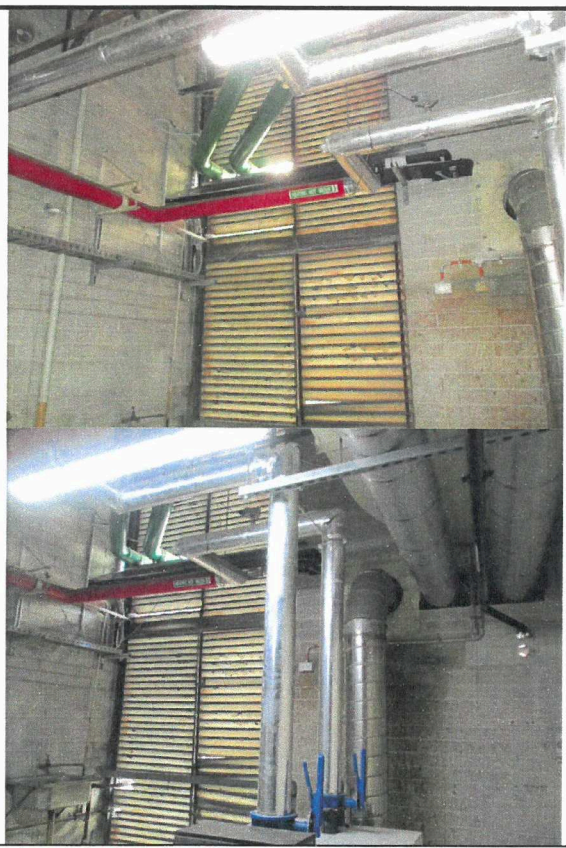
ID 11:- Hot Water Pipe Insulation (Suspected Synthetic Mineral Fibres)	
Material	Suspected synthetic mineral fibres.
Lab No.	Observed.
QED Sample No.	N/A.
Locations	Level 7 Plantroom; All floors.
Condition	Good.
Signage	N/A.
Potential for Disturbance	Low.
Risk	Minor
Management Actions	Minimise disturbance / handling. Appropriate PPE required when disturbing, at least a P2 Mask. Removal by an appropriate contractor.
References (See Appendices)	National Code of Practice for the Safe Use of Synthetic Mineral Fibres [NOHSC:2006(1990)].
Service Record	N/A.

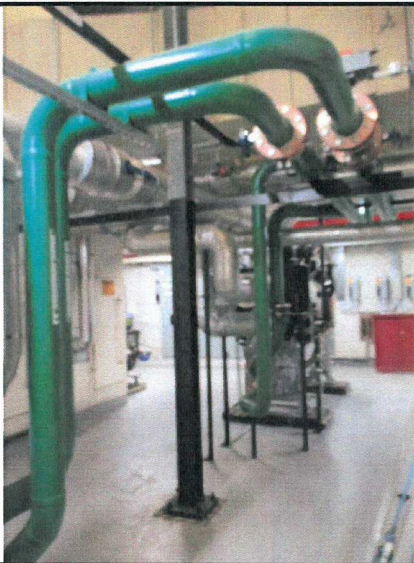
ID 12:- Cold Water Pipe Insulation (Suspected Synthetic Mineral Fibres)

Material	Suspected synthetic mineral fibres.	
Lab No.	Observed.	
QED Sample No.	N/A	
Locations	Chiller Plant Room and throughout building.	
Condition	Typically Good.	
Signage	N/A.	
Potential for Disturbance	Low.	
Risk	Minor	
Management Actions	Minimise disturbance / handling. Appropriate PPE required when disturbing, at least a P2 Mask. Removal by an appropriate contractor.	
References (See Appendices)	National Code of Practice for the Safe Use of Synthetic Mineral Fibres [NOHSC:2006(1990)].	
Service Record	N/A.

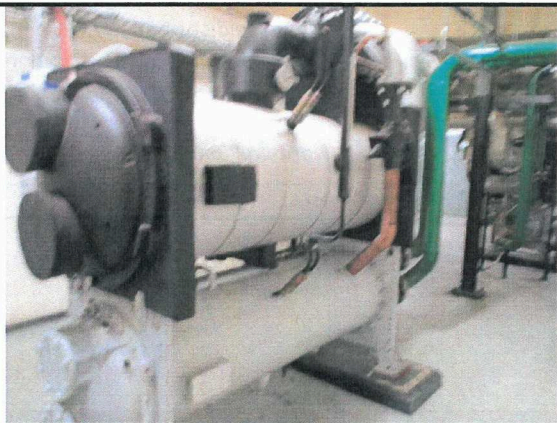
ID 13:- Chiller Insulation (Suspected Synthetic Mineral Fibres)

Material	Suspected synthetic mineral fibres.	
Lab No.	Observed.	
QED Sample No.	N/A	
Locations	Chiller Plant Room	
Condition	Typically Good.	
Signage	N/A.	
Potential for Disturbance	Low.	
Risk	Minor	
Management Actions	Minimise disturbance / handling. Appropriate PPE required when disturbing, at least a P2 Mask. Removal by an appropriate contractor.	
References (See Appendices)	National Code of Practice for the Safe Use of Synthetic Mineral Fibres [NOHSC:2006(1990)].	
Service Record	N/A.

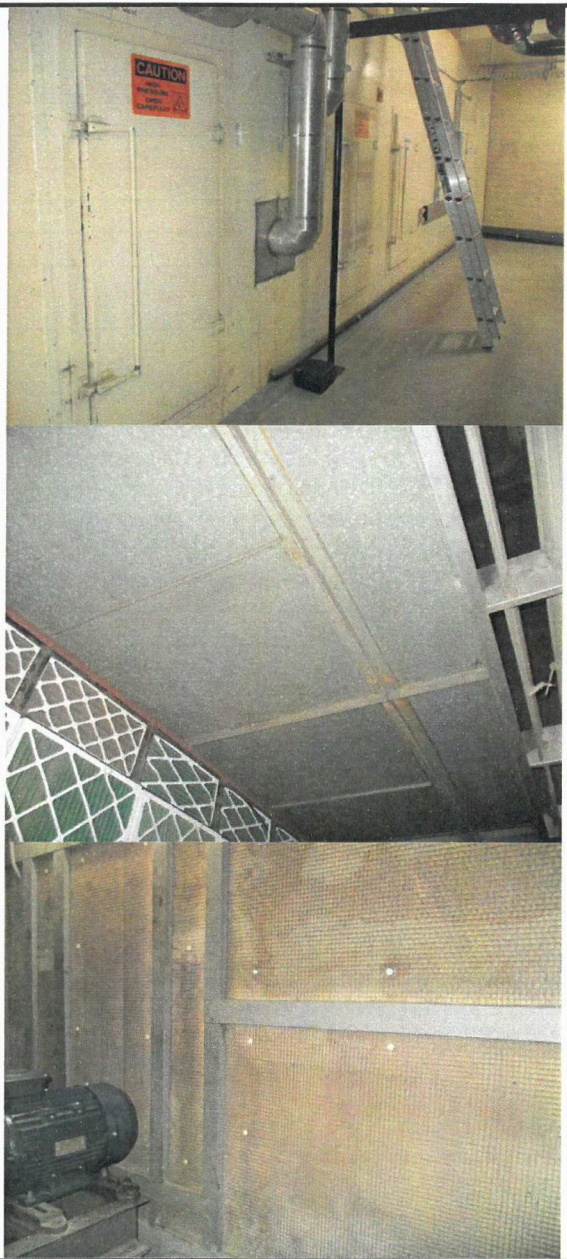
ID 14:- AHU Panel Insulation (Suspected Synthetic Mineral Fibres)

Material	Suspected synthetic mineral fibres.	
Lab No.	Observed.	
QED Sample No.	N/A	
Locations	AHUs, Plant Room	
Condition	Typically Good.	
Signage	N/A.	
Potential for Disturbance	Low.	
Risk	Minor	
Management Actions	Minimise disturbance / handling. Appropriate PPE required when disturbing, at least a P2 Mask. Removal by an appropriate contractor.	
References (See Appendices)	<i>National Code of Practice for the Safe Use of Synthetic Mineral Fibres [NOHSC:2006(1990)].</i>	
Service Record	N/A.

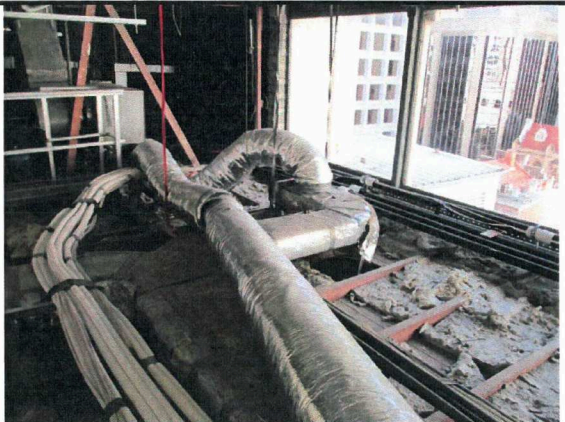
ID 15:- Ducting Insulation (Suspected Synthetic Mineral Fibres)

Material	Suspected synthetic mineral fibres.	
Lab No.	Observed.	
QED Sample No.	N/A	
Locations	Risers throughout.	
Condition	Typically Good.	
Signage	N/A.	
Potential for Disturbance	Low.	
Risk	Minor	
Management Actions	Minimise disturbance / handling. Appropriate PPE required when disturbing, at least a P2 Mask. Removal by an appropriate contractor.	
References (See Appendices)	National Code of Practice for the Safe Use of Synthetic Mineral Fibres [NOHSC:2006(1990)].	
Service Record	N/A.

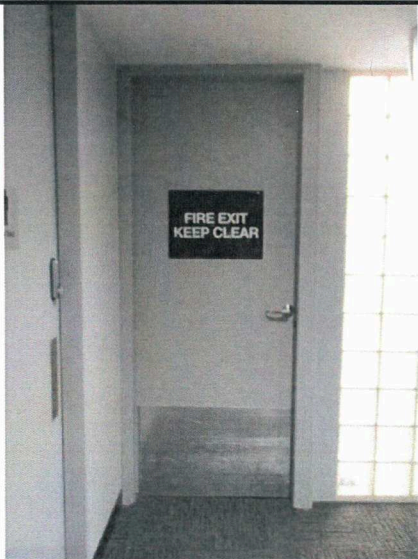
ID 16:- Fire Door Internal Insulation (Suspected Synthetic Mineral Fibres)

Material	Suspected synthetic mineral fibres.	
Lab No.	Observed. Installed 2003.	
QED Sample No.	QED 09511 (AEC report 97477) confirms non-asbestos.)	
Locations	Fire stairs throughout building.	
Condition	Good.	
Signage	N/A.	
Potential for Disturbance	Low.	
Risk	Minor	
Management Actions	Minimise disturbance / handling. Appropriate PPE required when disturbing, at least a P2 Mask. Removal by an appropriate contractor.	
References (See Appendices)	National Code of Practice for the Safe Use of Synthetic Mineral Fibres [NOHSC:2006(1990)].	
Service Record	N/A.

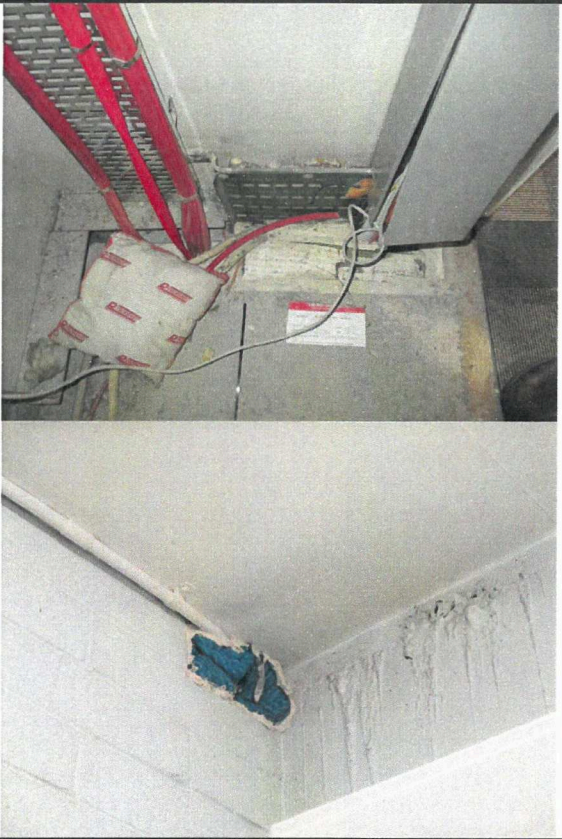
ID 17:- Fire Pillows (Suspected Synthetic Mineral Fibres)

Material	Suspected synthetic mineral fibres.	
Lab No.	Observed.	
QED Sample No.	N/A.	
Locations	Risers – Level 6 and Basement, Basement Electrical Room.	
Condition	Good.	
Signage	N/A.	
Potential for Disturbance	Low.	
Risk	Minor	
Management Actions	Minimise disturbance / handling. Appropriate PPE required when disturbing, at least a P2 Mask. Removal by an appropriate contractor.	
References (See Appendices)	<i>National Code of Practice for the Safe Use of Synthetic Mineral Fibres [NOHSC:2006(1990)].</i>	
Service Record	N/A.

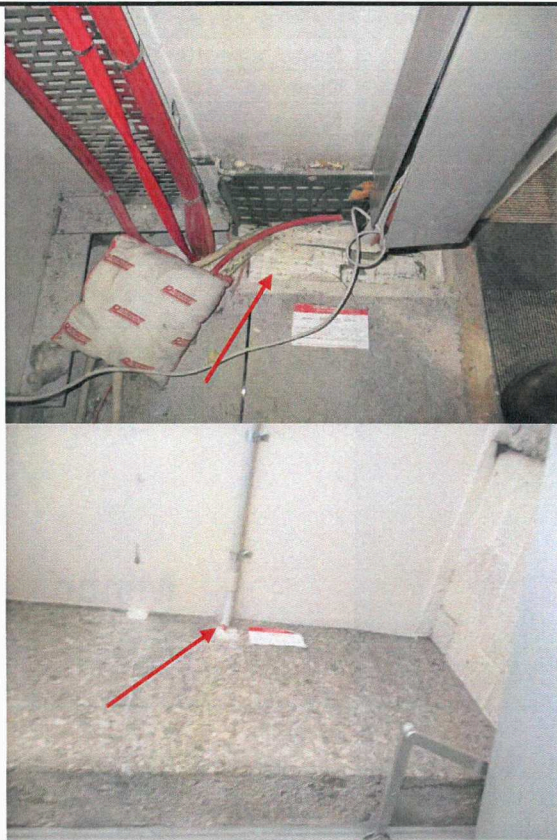
ID 18:- FireStop Insulation (Suspected Synthetic Mineral Fibres)

Material	Suspected synthetic mineral fibres.	
Lab No.	Observed.	
QED Sample No.	N/A.	
Locations	Risers – all floors and fire penetrations above fire doors.	
Condition	Good.	
Signage	N/A.	
Potential for Disturbance	Low.	
Risk	Minor	
Management Actions	Minimise disturbance / handling. Appropriate PPE required when disturbing, at least a P2 Mask. Removal by an appropriate contractor.	
References (See Appendices)	<i>National Code of Practice for the Safe Use of Synthetic Mineral Fibres [NOHSC:2006(1990)].</i>	
Service Record	N/A.

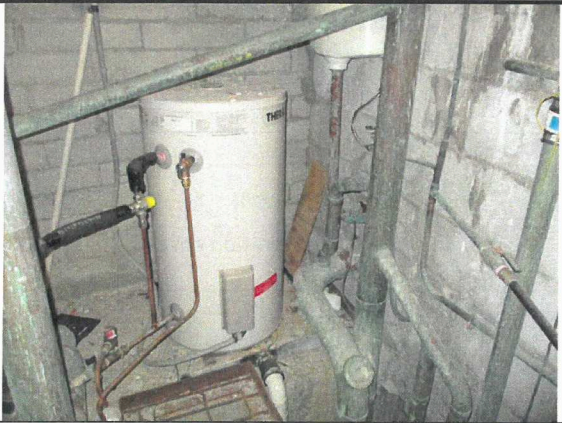
ID 19:- Domestic Hot Water Heater Insulation (Suspected Synthetic Mineral Fibres)

Material	Suspected synthetic mineral fibres.	
Lab No.	Observed.	
QED Sample No.	N/A.	
Locations	Plumbing Ducts.	
Condition	Good, encapsulated within the unit.	
Signage	N/A.	
Potential for Disturbance	Low.	
Risk	Minor	
Management Actions	Minimise disturbance / handling. Appropriate PPE required when disturbing, at least a P2 Mask. Removal by an appropriate contractor.	
References (See Appendices)	<i>National Code of Practice for the Safe Use of Synthetic Mineral Fibres [NOHSC:2006(1990)].</i>	
Service Record	N/A.

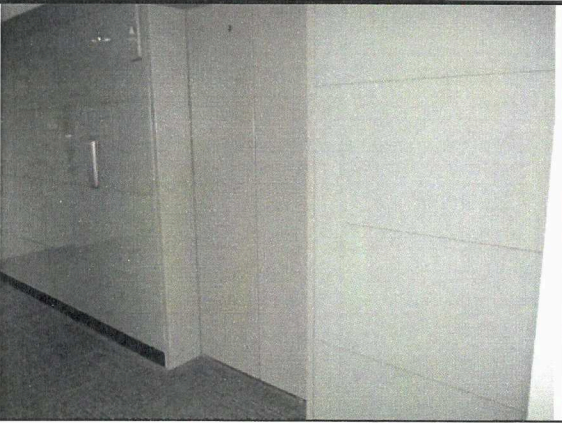
ID 20:- Lift Door Thermal Insulation (Synthetic Mineral Fibres Detected)

Material	Synthetic mineral fibres.	
Lab No.	Greencap Lab Report No. 99935.	
QED Sample No.	QED: ID: 09125.	
Locations	Within the doors to the lift.	
Condition	Good, encapsulated within the doors.	
Signage	Labelled on Lift Motor Room door.	
Potential for Disturbance	Low.	
Risk	Minor	
Management Actions	Minimise disturbance / handling. Appropriate PPE required when disturbing, at least a P2 Mask. Removal by an appropriate contractor.	
References (See Appendices)	<i>National Code of Practice for the Safe Use of Synthetic Mineral Fibres [NOHSC:2006(1990)].</i>	
Service Record	N/A.

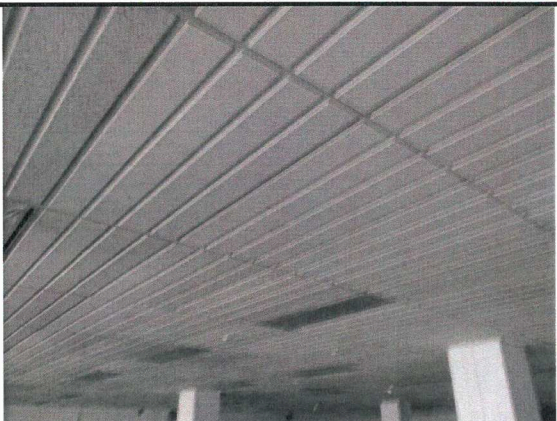
ID 21:- Tenancy Ceiling Tiles & Insulation (Suspected Synthetic Mineral Fibres)

Material	Suspected synthetic mineral fibres.	
Lab No.	Observed.	
QED Sample No.	N/A.	
Locations	Tenancies – all floors. Also used as a penetration cover within the plumbing ducts.	
Condition	Typically Good.	
Signage	N/A.	
Potential for Disturbance	Low.	
Risk	Minor	
Management Actions	Minimise disturbance / handling. Appropriate PPE required when disturbing, at least a P2 Mask. Removal by an appropriate contractor.	
References (See Appendices)	National Code of Practice for the Safe Use of Synthetic Mineral Fibres [NOHSC:2006(1990)].	
Service Record	N/A.

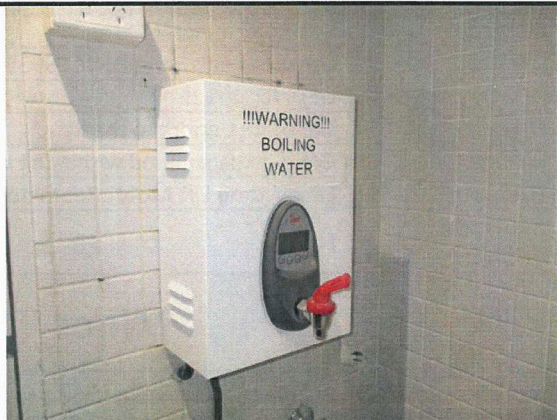
ID 22:- Water Boiler Insulation (Suspected Synthetic Mineral Fibres)

Material	Suspected synthetic mineral fibres.	
Lab No.	Observed.	
QED Sample No.	N/A	
Locations	Kitchenettes on each level.	
Condition	Typically Good.	
Signage	N/A.	
Potential for Disturbance	Low.	
Risk	Minor	
Management Actions	Minimise disturbance / handling. Appropriate PPE required when disturbing, at least a P2 Mask. Removal by an appropriate contractor.	
References (See Appendices)	National Code of Practice for the Safe Use of Synthetic Mineral Fibres [NOHSC:2006(1990)].	
Service Record	N/A.

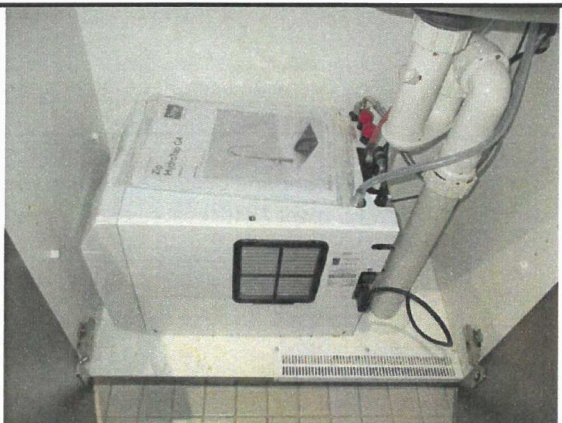
ID 23:- Water Boiler/ Water Cooler Insulation (Suspected Synthetic Mineral Fibres)

Material	Suspected synthetic mineral fibres.	
Lab No.	Observed.	
QED Sample No.	N/A	
Locations	Tenancy Kitchens.	
Condition	Typically Good.	
Signage	N/A.	
Potential for Disturbance	Low.	
Risk	Minor	
Management Actions	Minimise disturbance / handling. Appropriate PPE required when disturbing, at least a P2 Mask. Removal by an appropriate contractor.	
References (See Appendices)	<i>National Code of Practice for the Safe Use of Synthetic Mineral Fibres [NOHSC:2006(1990)].</i>	
Service Record	N/A.

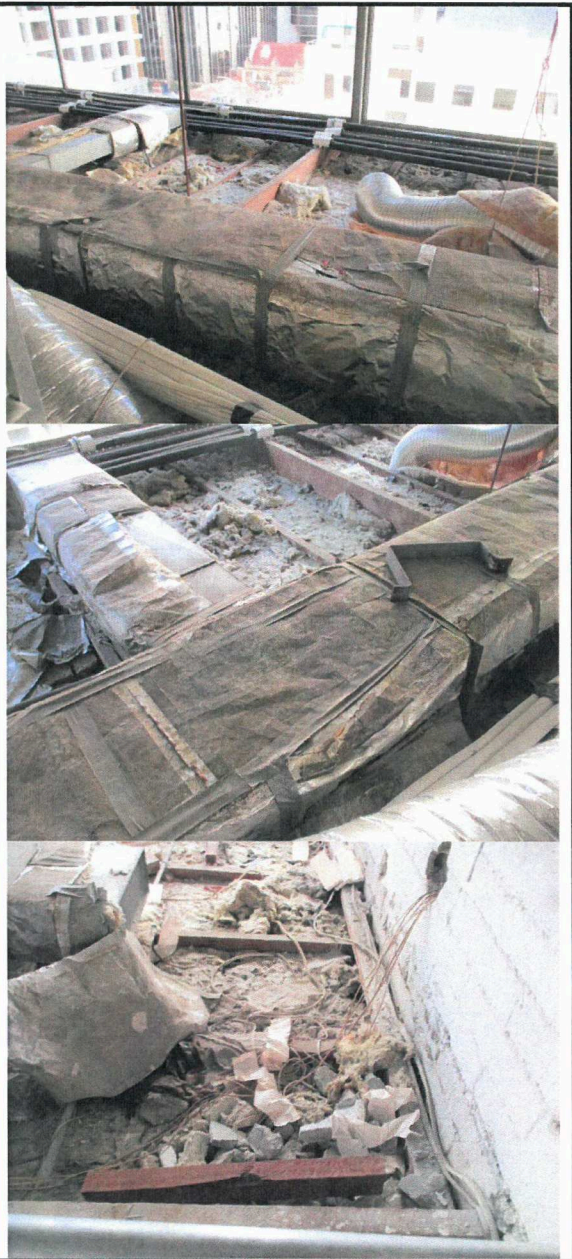
ID 24:- Loose Roof Insulation (Suspected Synthetic Mineral Fibres)	
Material	Suspected synthetic mineral fibres.
Lab No.	Observed.
QED Sample No.	N/A
Locations	Floor and Ceiling, old Penthouse above Level 7 office, accessed via the Plant Room.
Condition	Poor. Loose and unsealed, with loose pieces on the ceiling.
Signage	N/A.
Potential for Disturbance	Moderate.
Risk	Moderate
Management Actions	Minimise disturbance / handling. Appropriate PPE required when disturbing, at least a P2 Mask. Removal by an appropriate contractor.
References (See Appendices)	National Code of Practice for the Safe Use of Synthetic Mineral Fibres [NOHSC:2006(1990)].
Service Record	N/A.

ID #	Product	Location
24	Loose, unsealed ceiling insulation	Level 7 Tenancy ceiling space and ceiling in plant room/penthouse above.
IMMEDIATE ACTION REQUIRED. The insulation requires encapsulation or replacement with a non-loose style of insulation.

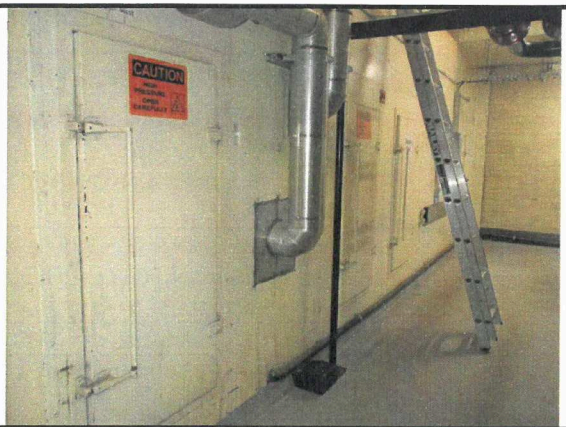
ID 25:- Lead Paint (Lead Detected)

Material	Lead based paint (3.6%.)	
Lab No.	MPL Lab No. 146783-1.	
QED Sample No.	3526.	
Locations	AC Plantroom.	
Condition	Good.	
Signage	N/A.	
Potential for Disturbance	Low.	
Risk	Minor	
Management Actions	Minimise disturbance / handling. Avoid dry sanding or blast cleaning. Appropriate PPE required when disturbing. Removal by an appropriate contractor as required.	
References (See Appendices)	AS 4361.2:2017 <i>Guide to Hazardous Paint Management; Part 2: Lead paint in residential, public and commercial buildings.</i>	
Service Record	N/A.	
Further Details	In 2017, the Australian Standard (AS4361.2) redefined the definition of lead paint, reducing the concentration of lead from 1% to 0.1%w/w for the paint to be classified as lead paint.

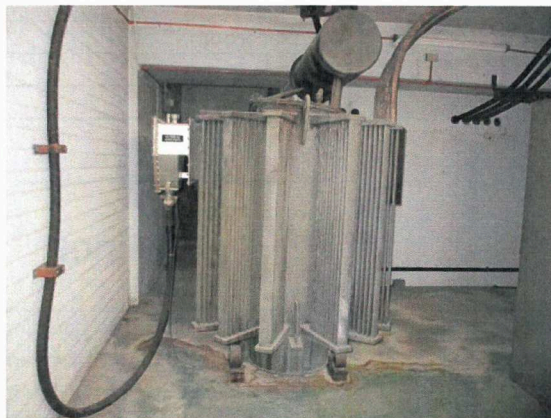
ID 26:- Transformer Capacitor Oil (Suspected PCB Containing)	
Material	Suspected PCB (poly chlorinated bi-phenyl) containing capacitor. Further identification required upon removal.
Lab No.	Not listed in ANZECC – 1997 publication <i>Identification of PCB Containing Capacitors</i> .
QED Sample No.	N/A – Live, cannot be sampled.
Locations	Basement transformer room.
Condition	Good, sealed, no leaks.
Signage	N/A.
Potential for Disturbance	Low.
Risk	Minor
Management Actions	At removal, all PCB materials must be placed in a strong, sealed polyethylene bag, which is then placed in a sound, sealable metal drum. An absorbent material should be packed around the PCB equipment to absorb any leaks. The drum should then be sealed and labelled as "TOXIC - PCB waste" . Refer to PCB removal section in appendices.
References (See Appendices)	Refer to PCB removal section in appendices.

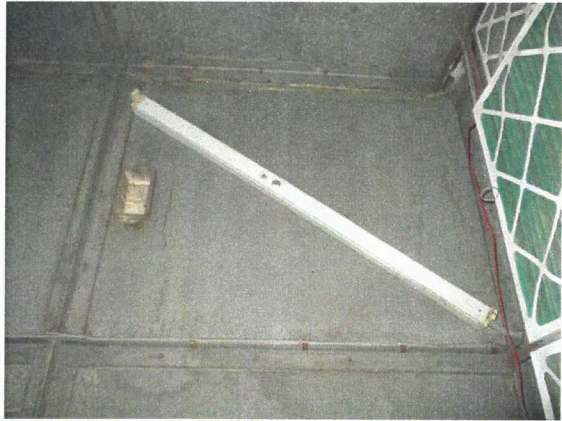
ID 27:- Fluorescent Lighting Capacitors (Suspected PCB Containing)

Material	Suspected PCB (poly chlorinated bi-phenyl) containing capacitor. Further identification required upon removal.	
Lab No.	Not listed in ANZECC – 1997 publication <i>Identification of PCB Containing Capacitors</i> .	
QED Sample No.	N/A	
Locations	Air Handling Units and potentially in older parts of the building.	
Condition	Good, sealed, no leaks.	
Signage	N/A.	
Potential for Disturbance	Low.	
Risk	Minor	
Management Actions	At removal, all PCB materials must be placed in a strong, sealed polyethylene bag, which is then placed in a sound, sealable metal drum. An absorbent material should be packed around the PCB equipment to absorb any leaks. The drum should then be sealed and labelled as "TOXIC - PCB waste" . Refer to PCB removal section in appendices.	
References (See Appendices)	Refer to PCB removal section in appendices.

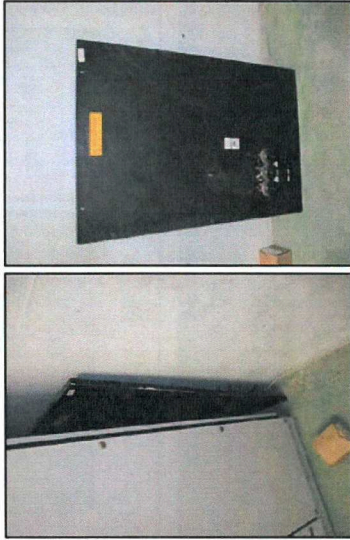
No asbestos detected
Electrical mounting boards	QED sample 09512 QED sample 06975 (2021) BL-0153 PB AEC Report 97477 Greencap SB28312 (2021)	Basement Transformer Room Electrical Cupboard

Boards were removed before the 2022 audit.
