# COMPLIANCE ASBESTOS RE-INSPECTION AND RISK ASSESSMENT

NOVEMBER 2021

J033447

ROCKHAMPTON NORTH CAMPUS\_Building 001 - Chancellery  
Bruce Highway  
ROCKHAMPTON NORTH QLD  
4700

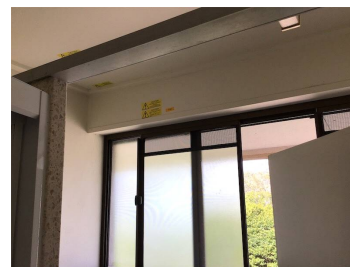
Location		001 Chancellery - 1st Floor - External - Sunhood ceiling - Fibre cement sheet - East elevation				
Hazard Type		Asbestos	Material Assessment		Disturbance Assessment	
Friability		Non-friable	Product Type	1	Occupancy	0
Sample No.		2-771 (AO000133)	Extent of damage	0	Disturbance	1
Result		Positive Chrysotile	Surface Treatment	1	Exposure	0
			Asbestos Type	1	Maintenance	0
Item Number		4	Material Score	3	Disturbance Score	1
			Priority Score	4	Very Low	
No Additional Photographic Evidence Available
