# COMPLIANCE ASBESTOS RE-INSPECTION AND RISK ASSESSMENT

NOVEMBER 2021

J033448

ROCKHAMPTON NORTH CAMPUS\_Building 002 - Student Admin  
Bruce Highway  
ROCKHAMPTON NORTH QLD  
4700

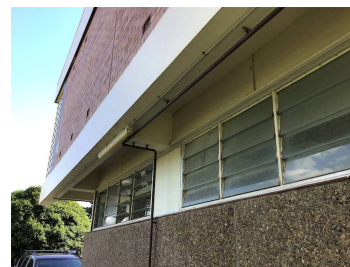
Location		002 Student Administration - Ground Floor - External - Infill panel - Fibre cement sheet - East elevation - above windows				
Hazard Type		Asbestos	Material Assessment		Disturbance Assessment	
Friability		Non-friable	Product Type	1	Occupancy	0
Sample No.		2-766 (AO000146)	Extent of damage	0	Disturbance	1
Result		Positive Chrysotile	Surface Treatment	1	Exposure	0
			Asbestos Type	1	Maintenance	0
Item Number		6	Material Score	3	Disturbance Score	1
			Priority Score	4	Very Low	
No Additional Photographic Evidence Available
