COMPLIANCE ASBESTOS RE-INSPECTION AND RISK ASSESSMENT

NOVEMBER 2021

J033452

ROCKHAMPTON NORTH CAMPUS_Building 015 - Animal House
Bruce Highway
ROCKHAMPTON NORTH QLD
4700

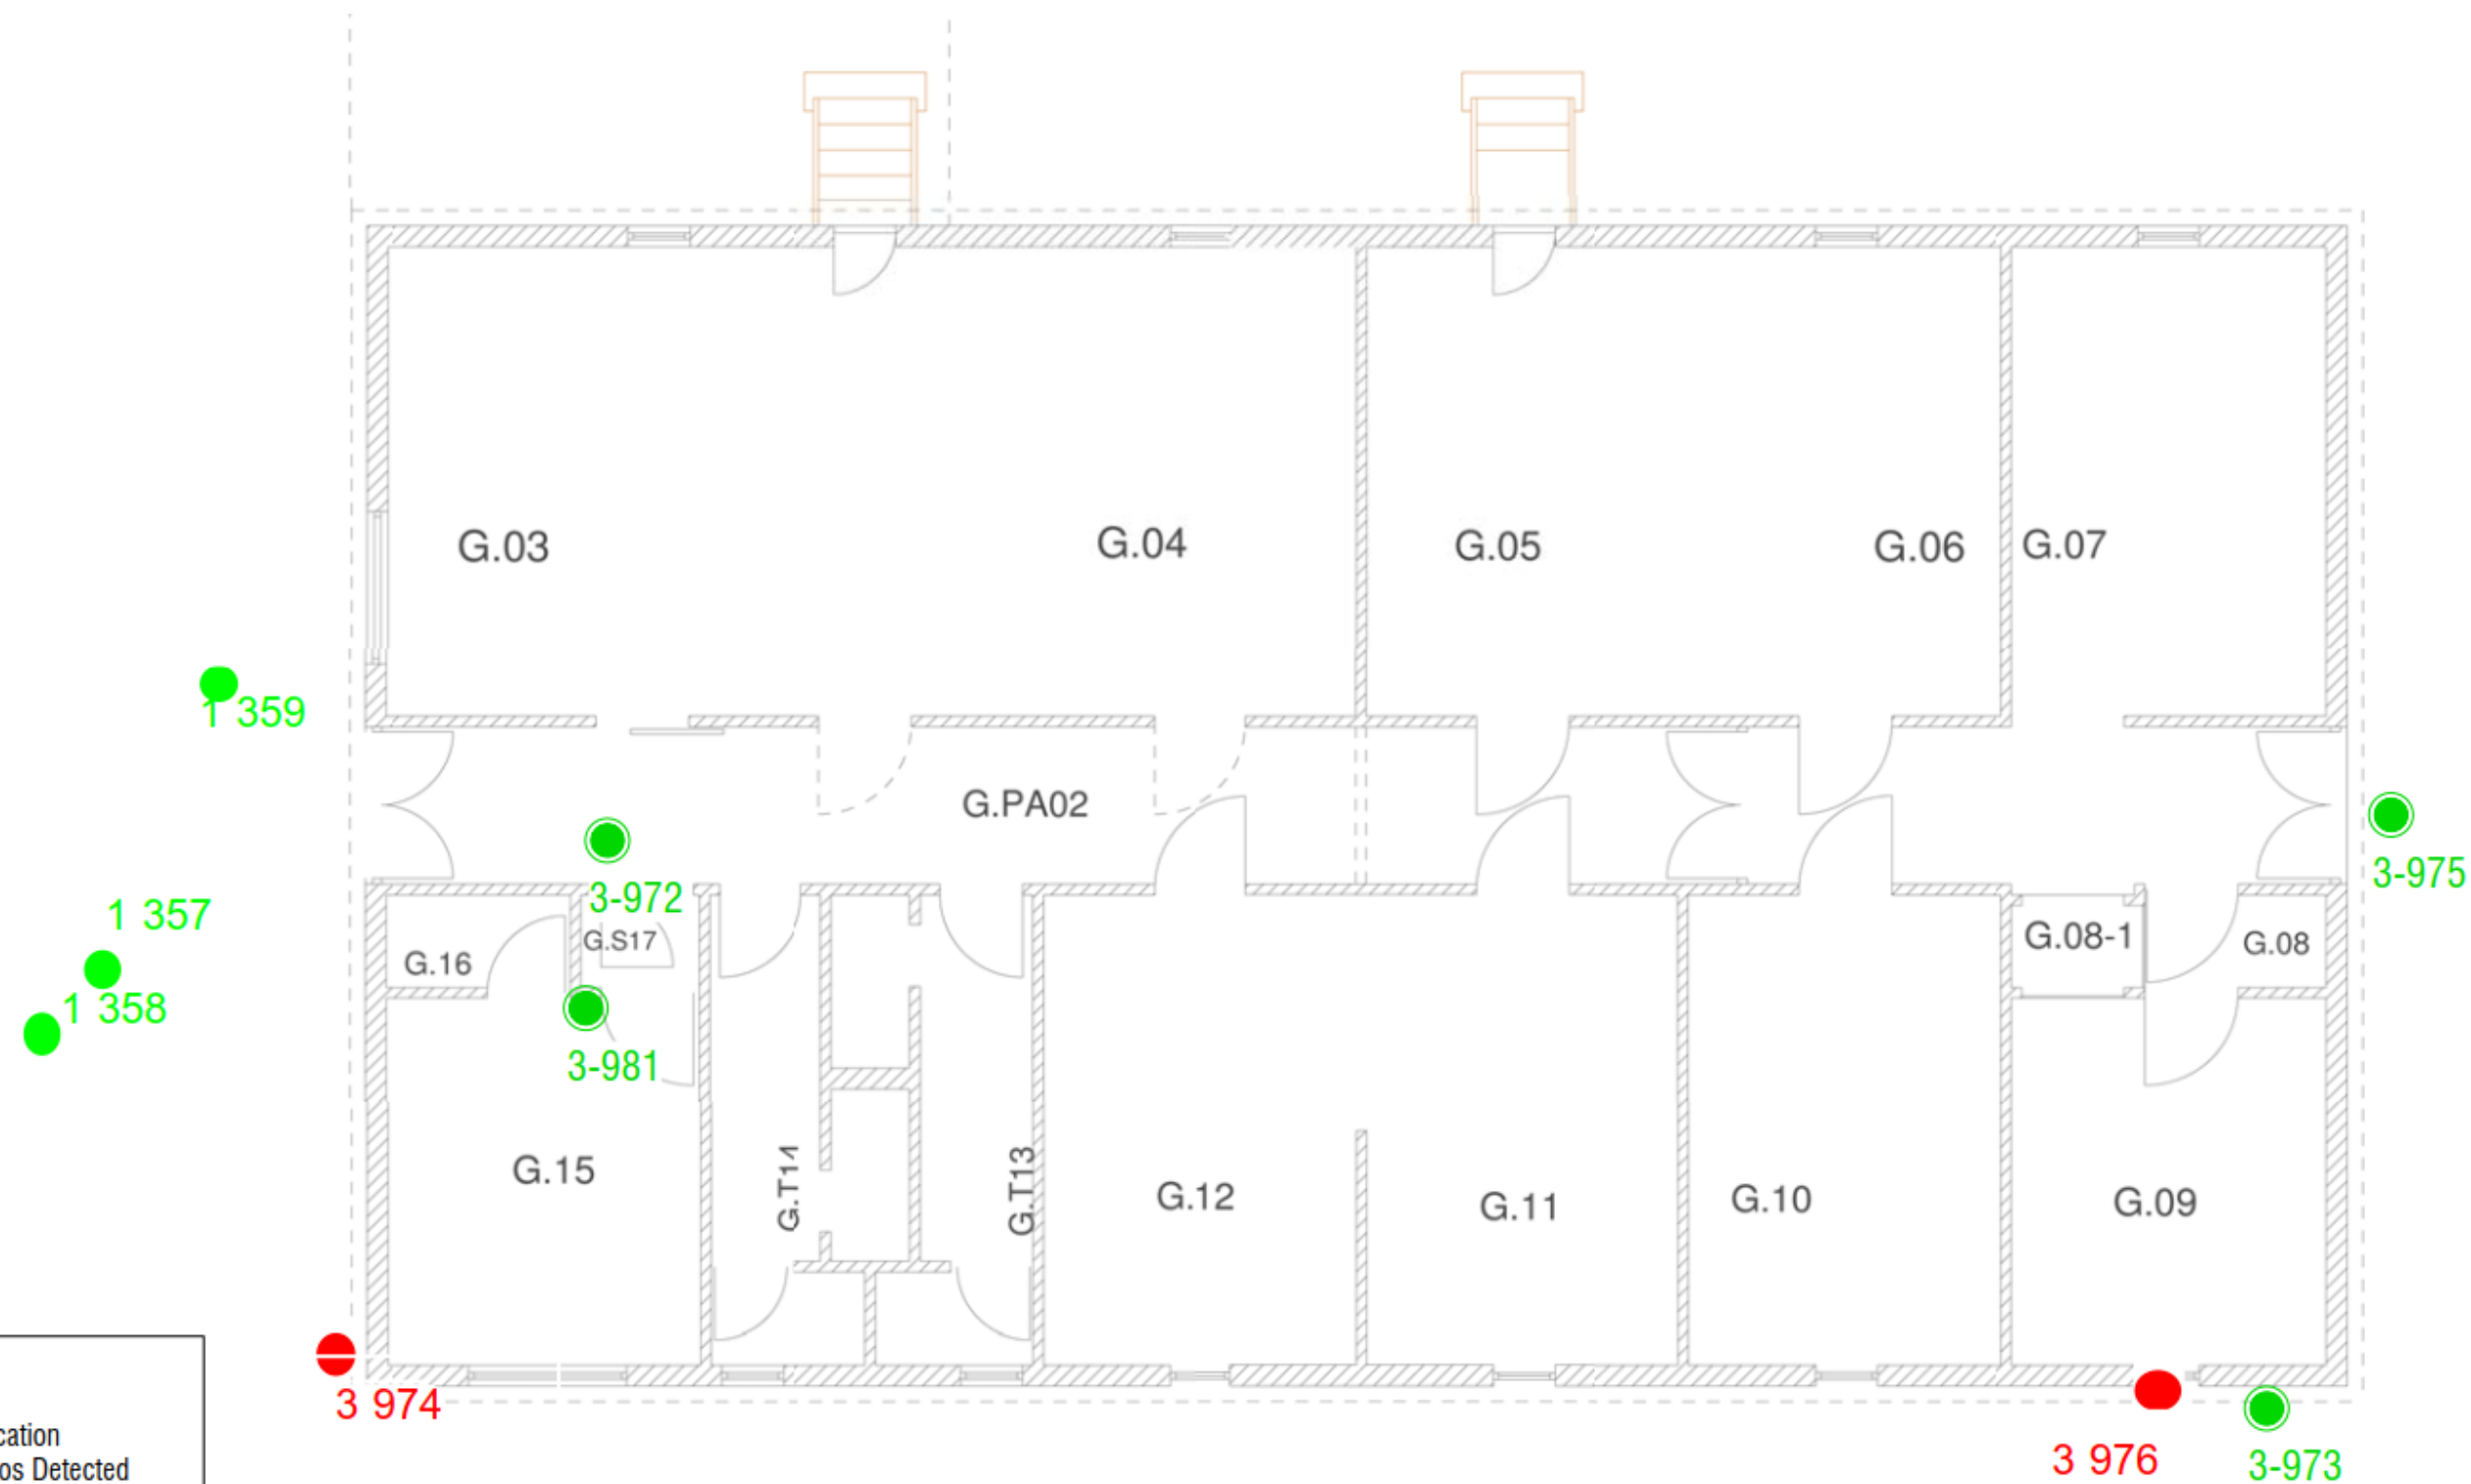
Hazard Type		Asbestos	Material Assessment		Disturbance Assessment		
Friability		Non-friable	Product Type	1	Occupancy		0
Sample No.		3-976 {AO000159}	Extent of damage	0	Disturbance		1
Result		Positive Chrysotile	Surface Treatment	1	Exposure		0
			Asbestos Type	1	Maintenance		0
Item Number		2	Material Score	3	Disturbance Score		1
			Priority Score	4	Very Low		
No Additional Photographic Evidence Available
