COMPLIANCE ASBESTOS RE-INSPECTION AND RISK ASSESSMENT

J033427

C126956 CQ University Australia

BUNDABERG CAMPUS_Campus Grounds
Isis Highway
Bundaberg QLD
4670

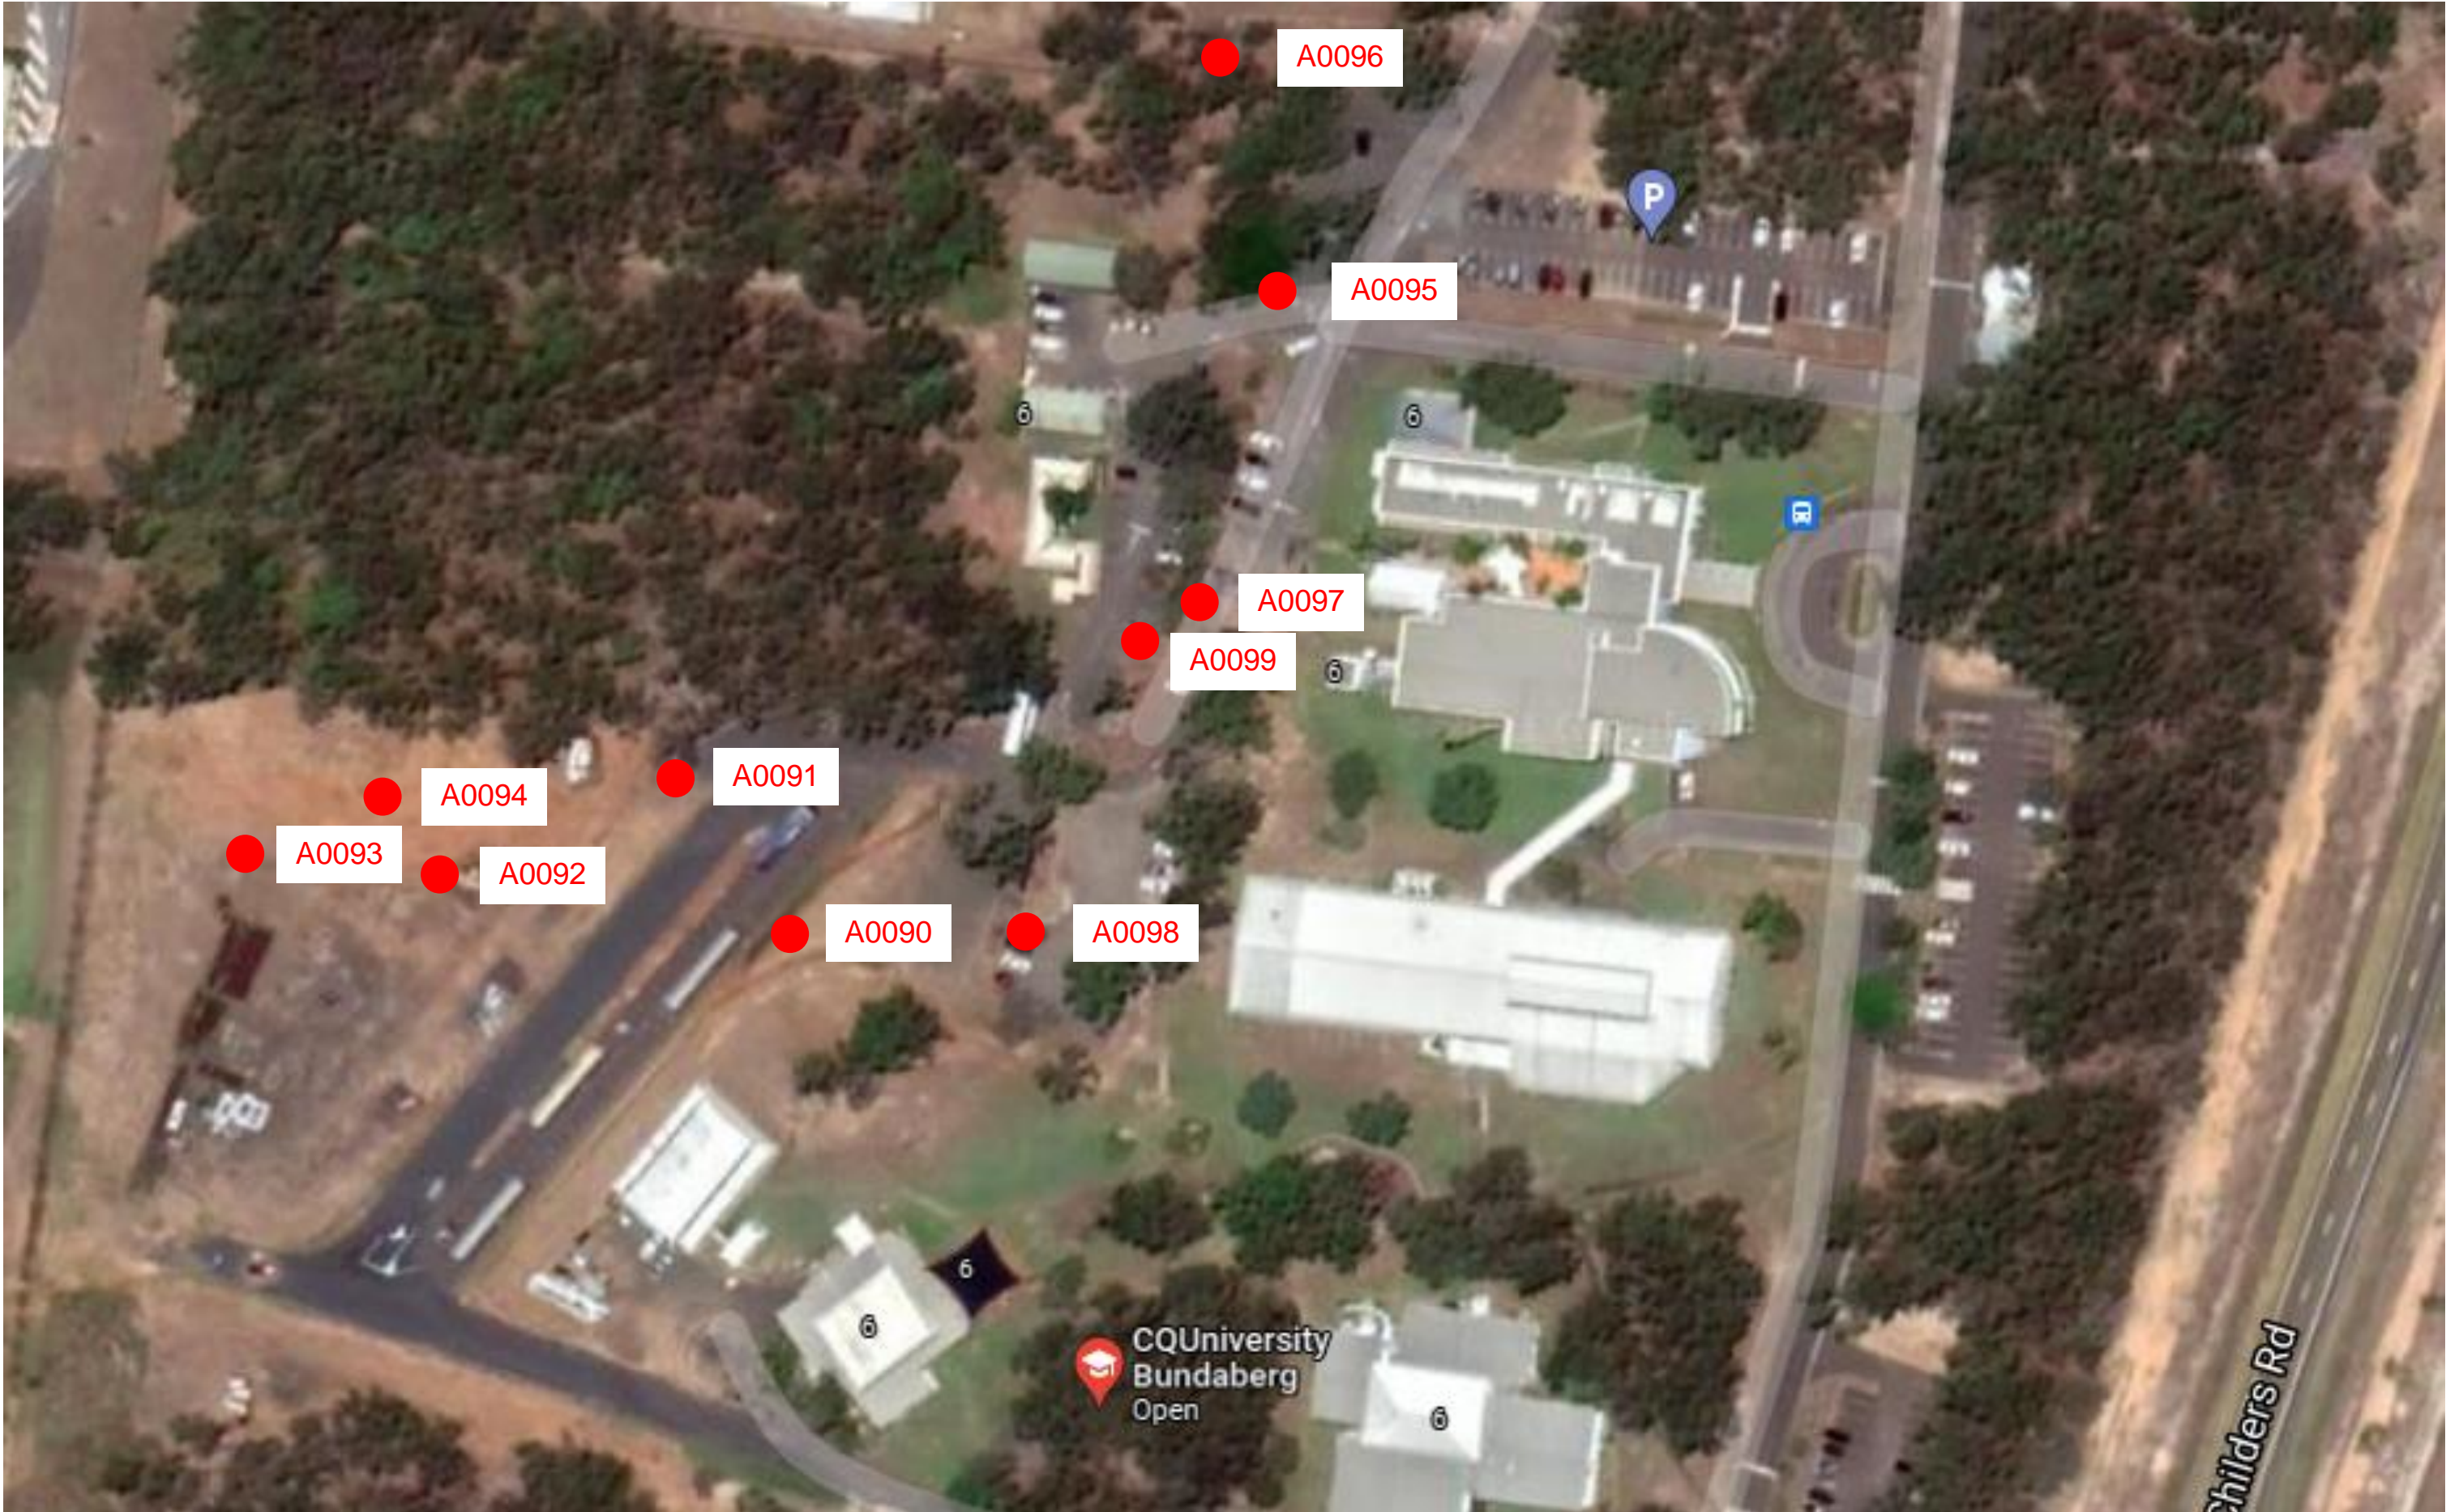
Item No.	Hazard Type	Item Location and Description	Recommendations
Item 7	Asbestos	Campus Grounds, Ground Floor, Admin Car Park, -24.898323, 152.312297, Debris - Fibre cement sheet	Remove Under Suitably Controlled Conditions

Item 8	Asbestos	Campus Grounds, Ground Floor, Admin Car Park, -24.897947, 152.312165, Debris - Fibre cement sheet	Remove Under Suitably Controlled Conditions

Item 9	Asbestos	Campus Grounds, Ground Floor, Admin Car Park, -24.898838, 152.312127, Debris - Fibre cement sheet	Remove Under Suitably Controlled Conditions

Item 10	Asbestos	Campus Grounds, Ground Floor, Admin Car Park, -24.899304, 152.311872, Debris - Fibre cement sheet	Remove Under Suitably Controlled Conditions

Item 11	Asbestos	Campus Grounds, Ground Floor, Admin Car Park, -24.898867, 152.312029, Debris - Fibre cement sheet	Remove Under Suitably Controlled Conditions

Item 2	Asbestos	Campus Grounds, Ground Floor, Forensic Crash Lab Grounds, -24.899345, 152.311433, Debris - Fibre cement sheet	Remove Under Suitably Controlled Conditions

Item 3	Asbestos	Campus Grounds, Ground Floor, Forensic Crash Lab Grounds, -24.899081, 152.311287, Debris - Fibre cement sheet	Remove Under Suitably Controlled Conditions

Item 4	Asbestos	Campus Grounds, Ground Floor, Forensic Crash Lab Grounds, -24.899258, 152.310832, Debris - Fibre cement sheet	Remove Under Suitably Controlled Conditions

Item 5	Asbestos	Campus Grounds, Ground Floor, Forensic Crash Lab Grounds, -24.899200, 152.310535, Debris - Fibre cement sheet	Remove Under Suitably Controlled Conditions

Item 6	Asbestos	Campus Grounds, Ground Floor, Forensic Crash Lab Grounds, -24.899115, 152.310705, Debris - Fibre cement sheet	Remove Under Suitably Controlled Conditions
