**ASBESTOS MATERIALS AUDIT  
REPORT AND REGISTER**

96 Buchan Street  
Portsmith  
Cairns QLD 4870

Assessment Conducted: 22<sup>nd</sup> September 2017  
Report No. CE129605

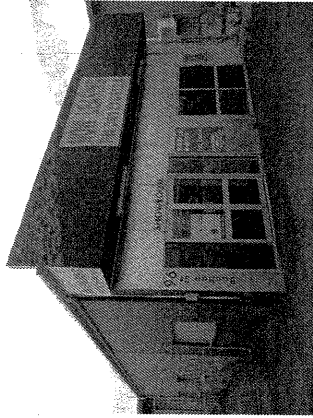
**96 Buchan Street**

Table 1. Asbestos and SMF Materials Register								
Survey Date: 22/09/2017		Address: 96 Buchan Street, Portsmith				Lab Report Number: CE129605		
Location	Material	Sample	Result	Condition	Friability	Disturb. Potential	Risk Rating	Comment
BUILDING FRONTAGE								
Eave	Fibro cement sheeting	CE129605- 1	NAD					
Fascia	Fibro cement sheeting	CE129605- 2	NAD
