COMPLIANCE ASBESTOS RE-INSPECTION AND RISK ASSESSMENT

NOVEMBER 2021

J033432

EMERALD CAMPUS_2 Maguire PI
2 Maguire PI
Emerald QLD
4720

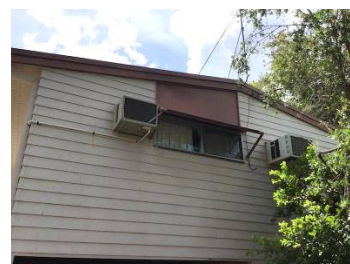
Location		2 Maguire Place - 1st Floor - External - East & West elevation Infill panels - Fibre cement sheet									
Hazard Type		Asbestos		Material Assessment		Disturbance Assessment					
Friability		Non-friable		Product Type		1		Occupancy		0	
Sample No.		Visual		Extent of damage		0		Disturbance		1	
Result		Assumed Positive Unknown or Crocidolite		Surface Treatment		1		Exposure		0	
				Asbestos Type		3		Maintenance		0	
Item Number		31		Material Score		5		Disturbance Score		1	
				Priority Score		6		Very Low
