# COMPLIANCE ASBESTOS RE-INSPECTION AND RISK ASSESSMENT

NOVEMBER 2021

J033468

ROCKHAMPTON NORTH CAMPUS\_RES Building 046 - Swanson Court - Block 5  
Bruce Highway  
ROCKHAMPTON NORTH QLD  
4700

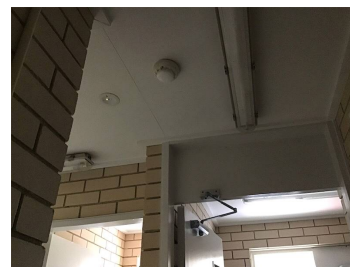
Location		046 Swanson Block 5 - Ground Floor - Female Bathroom - ThroughoutCeiling - Fibre cement sheet			
Hazard Type	Asbestos	Material Assessment		Disturbance Assessment	
Friability	Non-friable	Product Type	1	Occupancy	0
Sample No.	As 1-484 {AO000201}	Extent of damage	0	Disturbance	1
Result	Strongly Assumed Positive Chrysotile	Surface Treatment	1	Exposure	0
		Asbestos Type	1	Maintenance	0
Item Number	6	Material Score	3	Disturbance Score	1
		Priority Score	4	Very Low
