COMPLIANCE ASBESTOS RE-INSPECTION AND RISK ASSESSMENT

NOVEMBER 2021

J033477

ROCKHAMPTON NORTH CAMPUS_RES Building 061 - Jardine/Hopkins House Laundry
Bruce Highway
ROCKHAMPTON NORTH QLD
4700

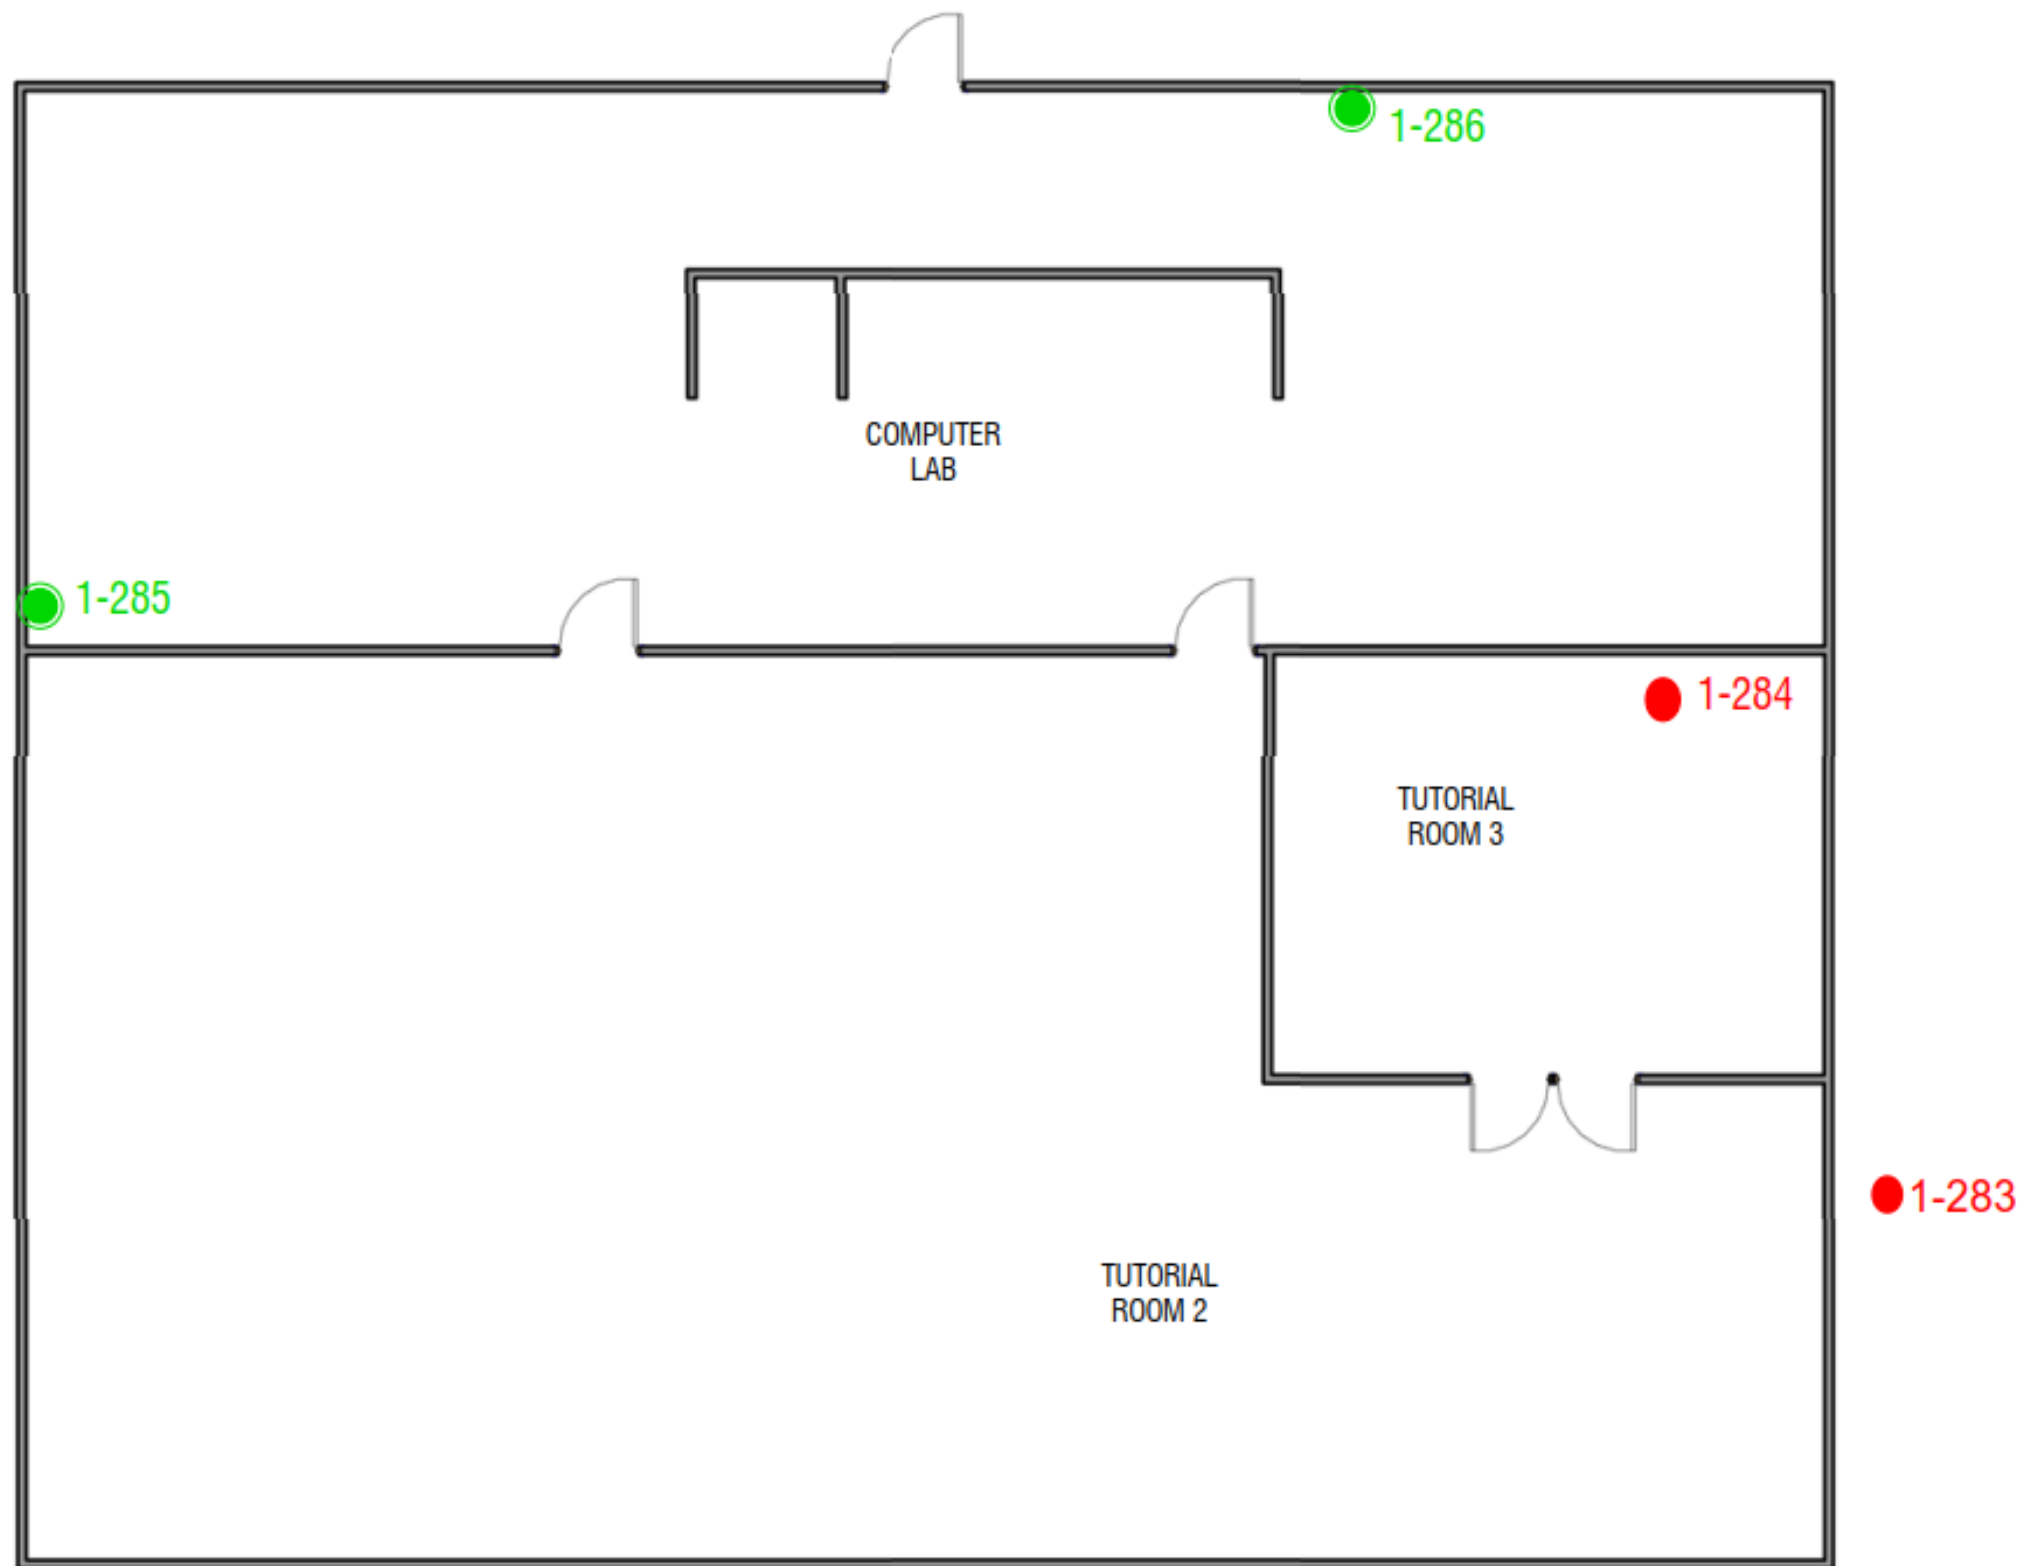
Hazard Type	Asbestos	Material Assessment		Disturbance Assessment	
Friability	Non-friable	Product Type	1	Occupancy	0
Sample No.	1-284 {AO000234}	Extent of damage	0	Disturbance	1
Result	Positive Chrysotile + Amosite	Surface Treatment	1	Exposure	0
		Asbestos Type	2	Maintenance	0
Item Number	2	Material Score	4	Disturbance Score	1
		Priority Score	5	Very Low
