Division 5 Asbestos Register

Re-Inspection Regulatory Compliance for Workplaces

99 Thistlethwaite Street
SOUTH MELBOURNE, VIC 3205

Report No : 1340.02.ARI Rev 0
Client : GMCCA Pty Ltd ATF Chan 2015 Family Trust
Surveyed : 27 November 2024
Issued : 20 December 2024

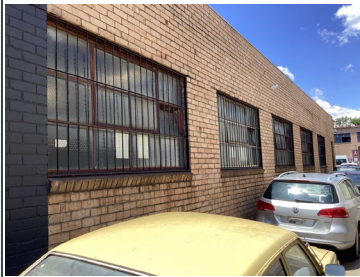
Location		Assessment Details		Risk	Photo	Controls
99 Thistlethwaite St - Exterior (... continued)						
	Windows Metal frames - putty	Method Sampled in Previous Audit (1340.01/AS02)	Outcome No Asbestos Detected	No Asbestos Risk Identified

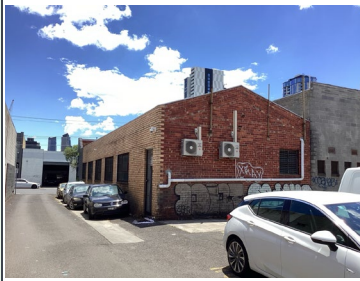
Throughout General construction (except as noted above) - brick walls & metal & plastic pipes to the rear wall	Method Visually Assessed	Outcome No Asbestos Identified	No Asbestos Risk Identified

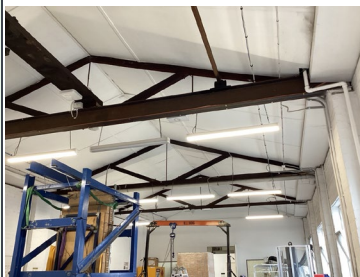
99 Thistlethwaite St - Interior						
	Main Warehouse Area Ceiling & boxing under gutters - timber	Method Visually Assessed	Outcome No Asbestos Identified	No Asbestos Risk Identified

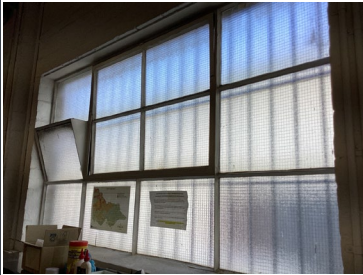
Location		Assessment Details	Risk	Photo	Controls
99 Thistlethwaite St - Interior (... continued)					
	Main Warehouse Area Windows - putty	Method Sampled in Previous Audit (1340.01/AS03) Outcome No Asbestos Detected	No Asbestos Risk Identified

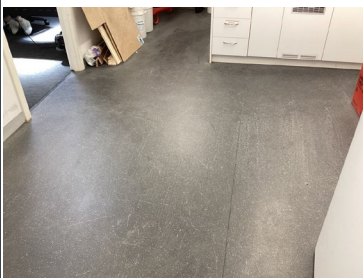
Staffroom Negative blue seamless vinyl floor cover replaced with new black seamless vinyl with non-asbestos characteristics Comment: Sample reference 1340. 01/AS04	Method Visually Assessed Outcome No Asbestos Identified	No Asbestos Risk Identified

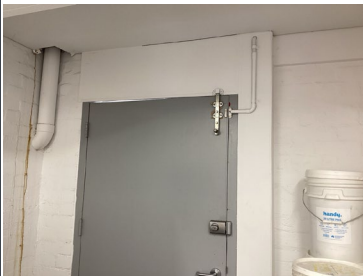
Staffroom Infill panel above & beside south-western door - cement sheeting	Method Sampled (GL012318) Outcome No Asbestos Detected	No Asbestos Risk Identified

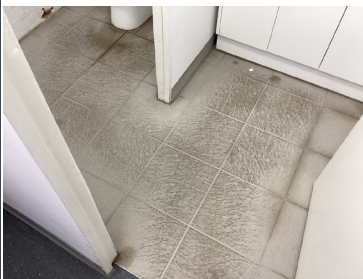
Location	Assessment Details	Risk	Photo	Controls
99 Thistlethwaite St - Interior (... continued)				
Toilet Negative blue seamless vinyl floor cover removed - ceramic floor tiles stuck straight onto concrete flooring <i>Comment: Reference sample 1340. 01/AS04</i>	Method Visually Assessed Outcome No Asbestos Identified	No Asbestos Risk Identified

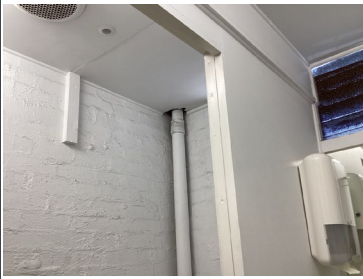
Toilet General construction (except as noted above) - wood fibre board ceilings, wood fibre board & brick walls, concrete flooring under floor covers	Method Visually Assessed Outcome No Asbestos Identified	No Asbestos Risk Identified

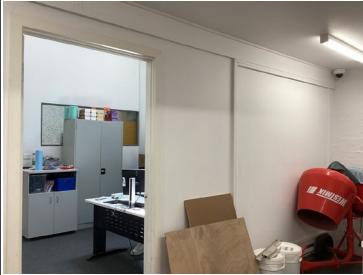
Throughout General construction (except as noted above) - plaster board & timber ceilings, plaster board, wood fibre board & brick walls, concrete flooring under floor covers	Method Visually Assessed Outcome No Asbestos Identified	No Asbestos Risk Identified
