ASBESTOS CONTAINING MATERIALS SURVEY REPORT

Temporary Academic Offices Rockhampton North

Report Number 622.10968.00000/0040-R01-ASR-Bld212

CQ University Building 37, Bruce Highway Rockhampton Queensland, 4702

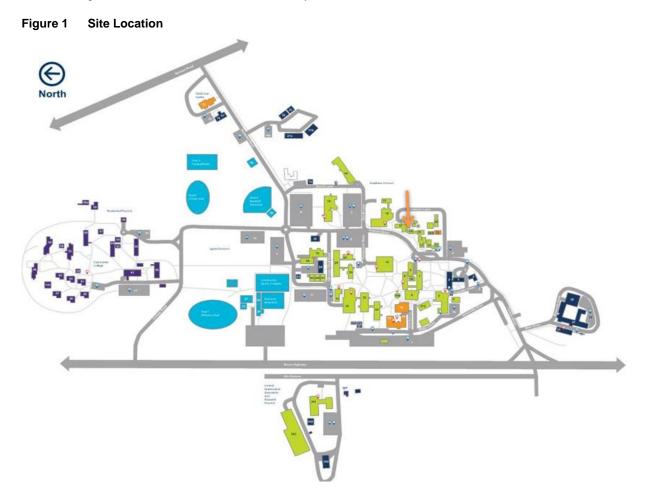
• The building was a single storey constructed circa 1992.

The building was in use, at the time of the survey as offices.
