## ASBESTOS CONTAINING MATERIALS SURVEY REPORT

Building 4  
Mackay City Tafe

Report Number 622.10968.00000-0080-R01-ASR-Building 4

09 November 2017

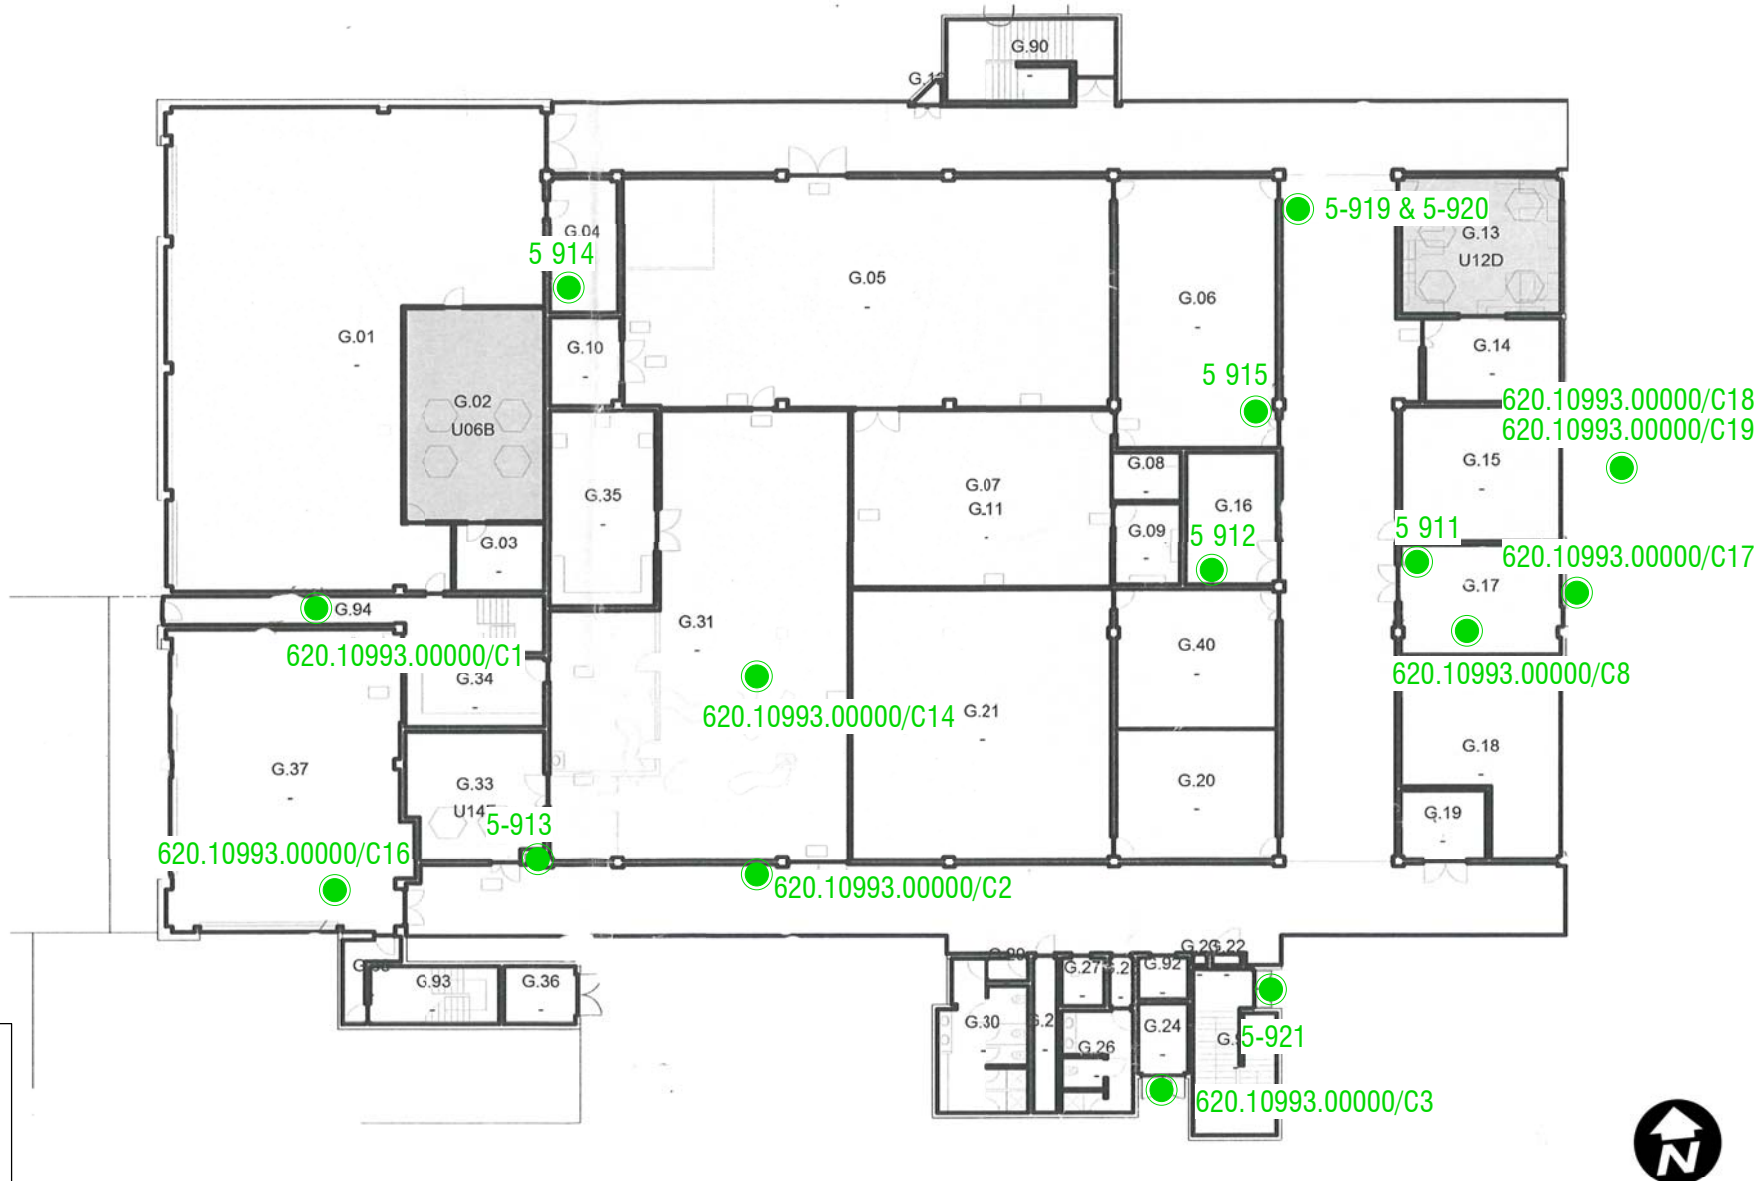
Site Plan

- Sample location
- No Asbestos Detected

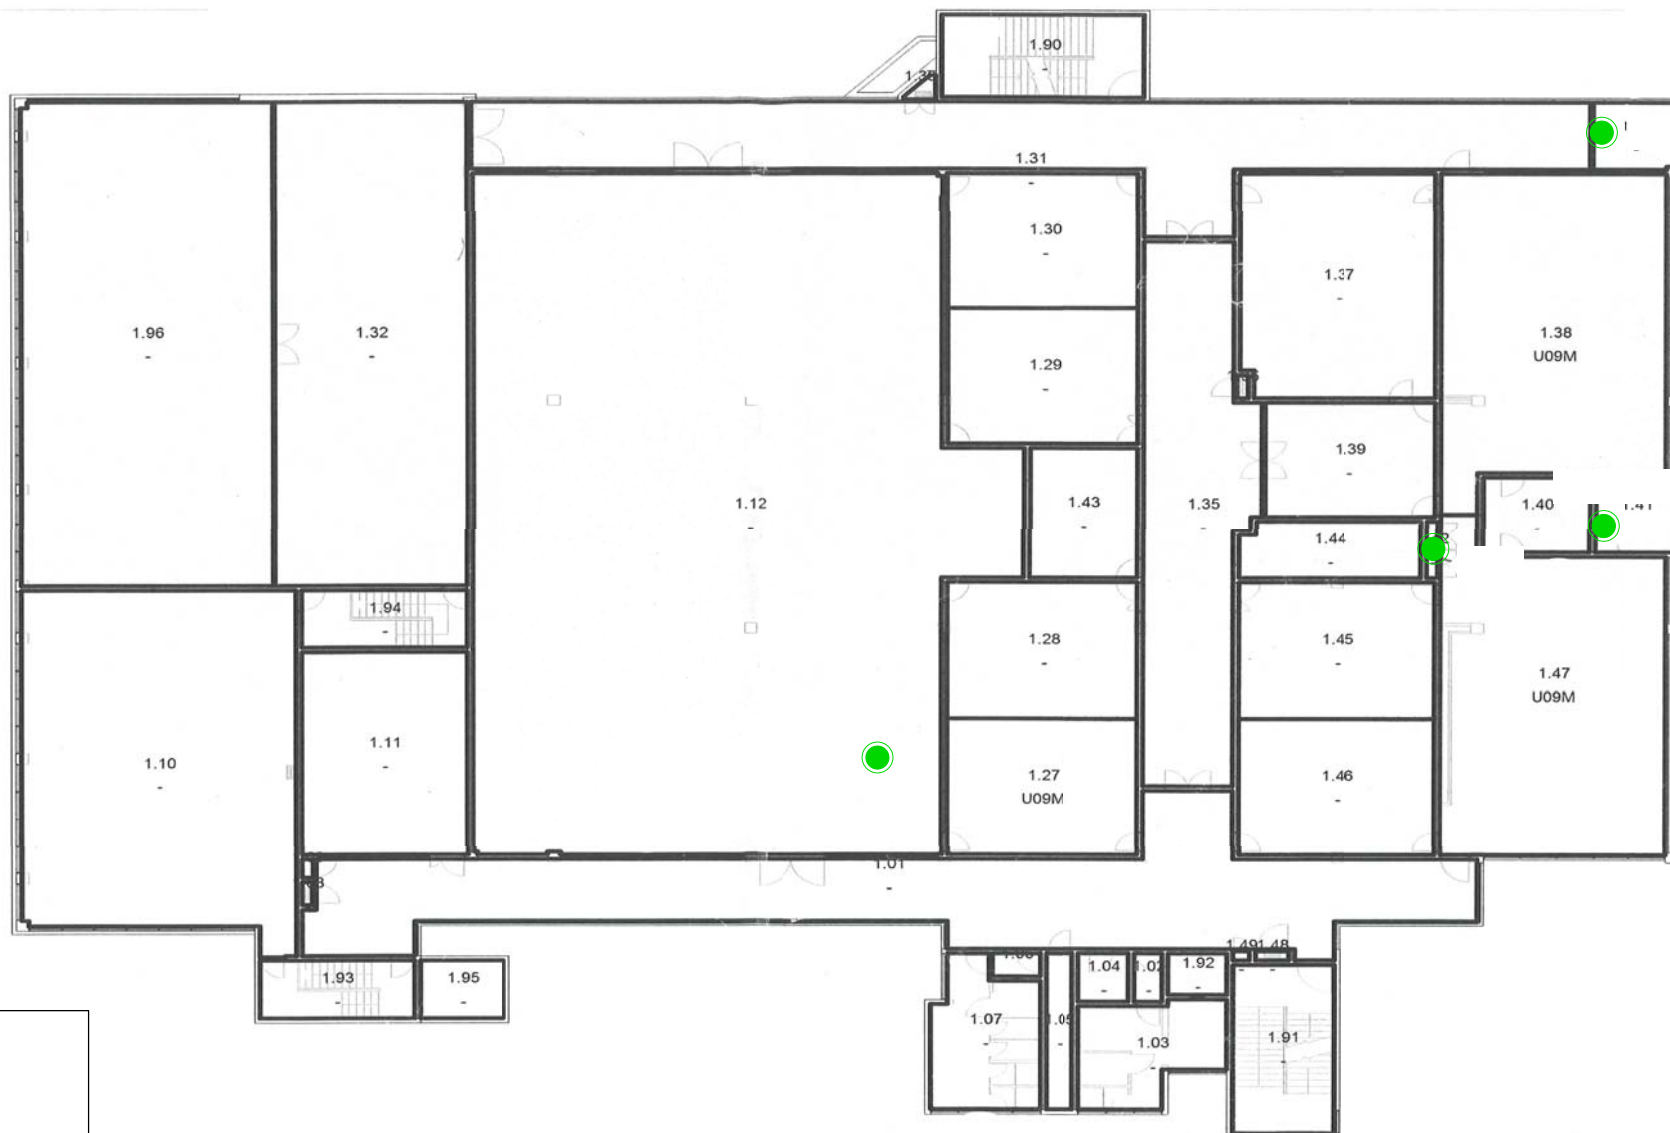
**Block C - Ground Level**  
**Sydney Street, Mackay,**  
**QLD 4740**

NOT TO SCALE FOR DIAGRAMMATIC PURPOSES ONLY
